AECSTechnical Article ~ Crowbar Cefiro

1996 V6 2.5 ltr petrol VQ25DE Nissan Cefiro, Japanese import

Problem presented to the help desk: The car presented to this YES member is a taxi and came in with a slight miss at low revs and seemingly on one cylinder only.

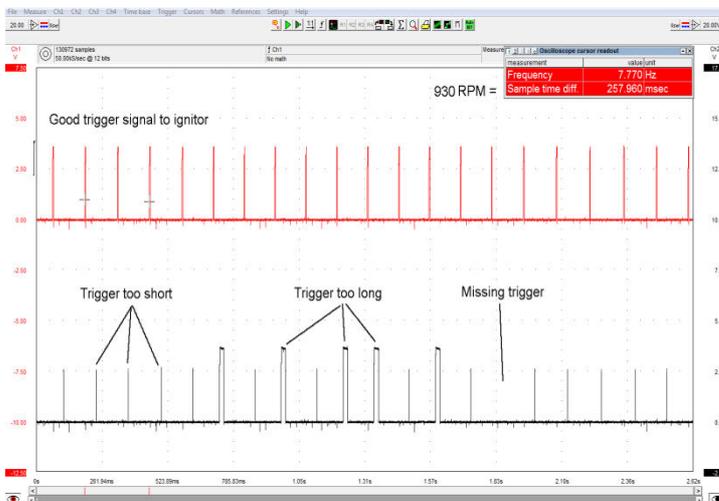
Figure 1 - ATS 2 channel scope recording of ignition

Please note, engine is 'misfiring' as a result of one coil not firing regularly on 2 sparkplugs.

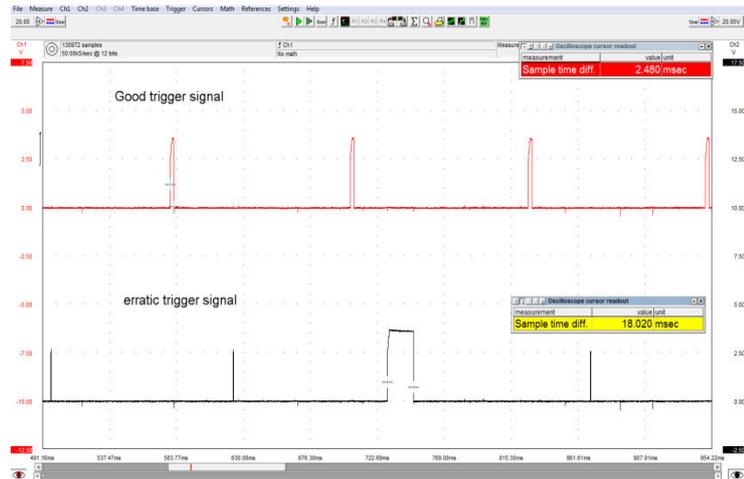
Figure 2 - ATS 2 channel scope recording of ignition

Same signal as in Figure 1, but zoomed in. Note the erratic trigger signal (too narrow and too wide) on CH2.

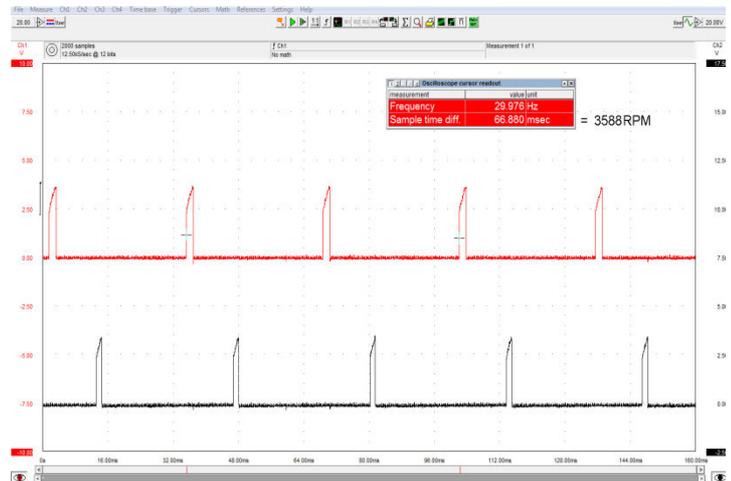
In Figure 3 Recorded signal on the same two coils during high revs. The ignition trigger on channel two is narrower than that on channel, but sufficient to make the coil ignite the mixture during low load (in the workshop).

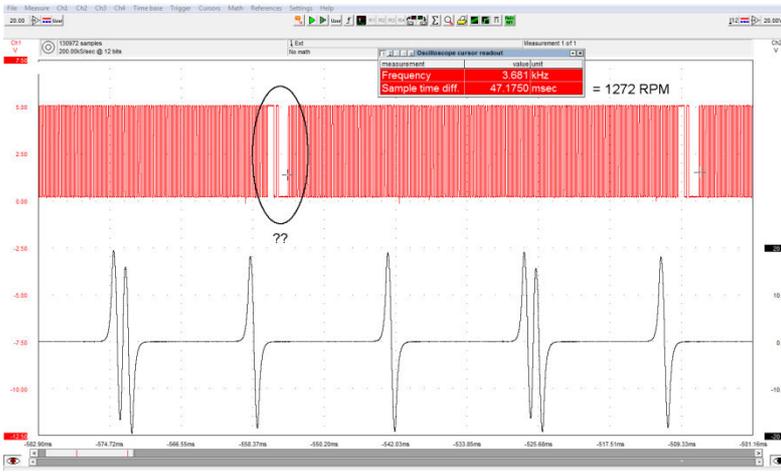
Figure 6 is a 2 channel recording of the Crank shaft front and rear sensor. Partially zoomed in on the 2 crankshaft sensor signals, to inspect the signal for irregularities. Instantly an irregularity on the hall sensor signal stands out, let's zoom in further (Figure 7)

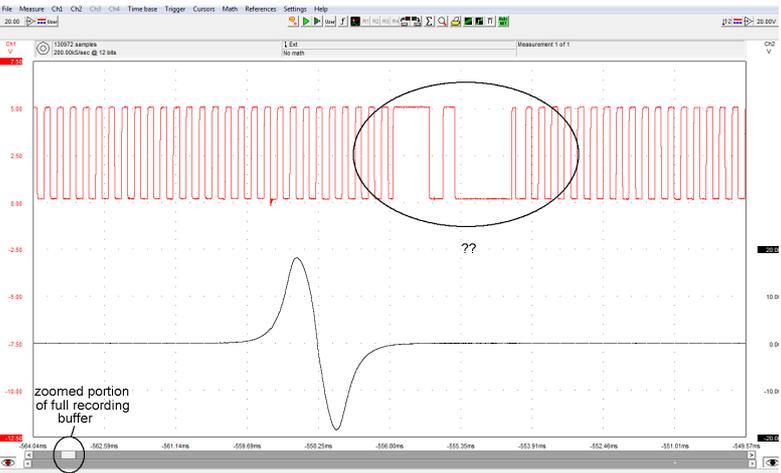
Figure 7

This Hall sensor pattern looks incorrect, let's compare with the ATIS scope data base.

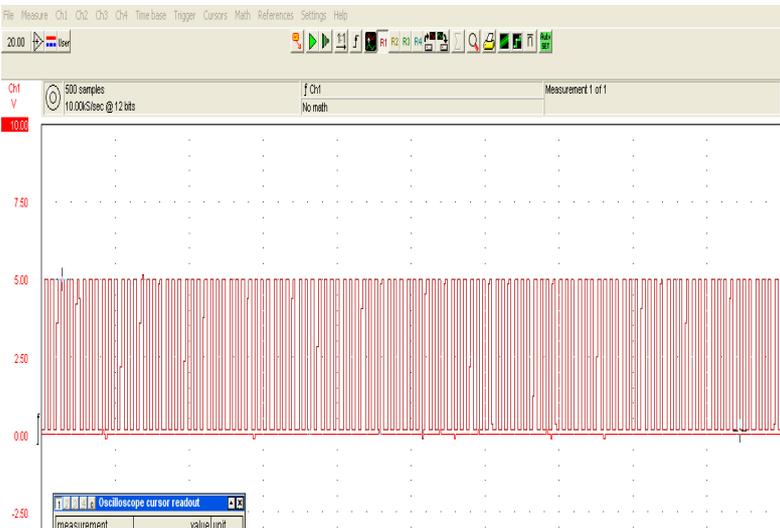
Figure 8

The data base does not show any irregularity in the Hall sensor signal, **problem found and verified.**

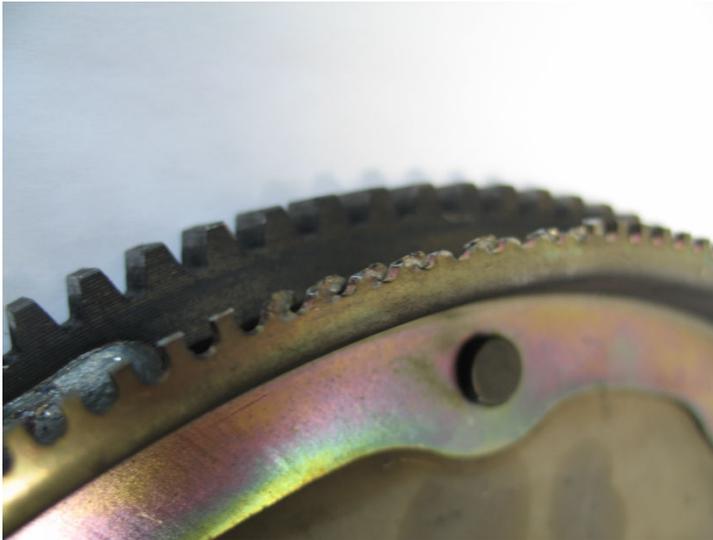
Figure 9

The sensor looks at its own ring gear with very weak teeth, compared to the strong teeth of the starter motor ring gear.

You have guessed it, a lazy mechanic held the crankshaft in position with a crow bar and in doing so damaged the sensor's ring gear as that was easier!

A new flywheel job as a result of a water pump job makes sense doesn't it?
