No go Nissan

This article is a true description of an AECS technical help desk problem and how it was solved.

Vehicle: Nissan Terrano R50 ZD30 DDTI 1999 Direct injected Diesel engine.

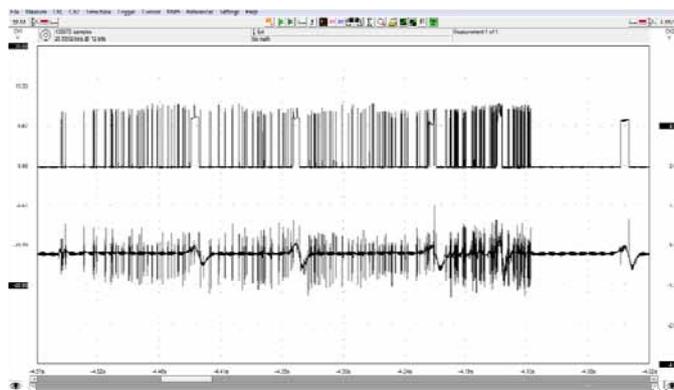
Zoomed in recording of the crank shaft sensor and RPM signal to the EDU during winding over.

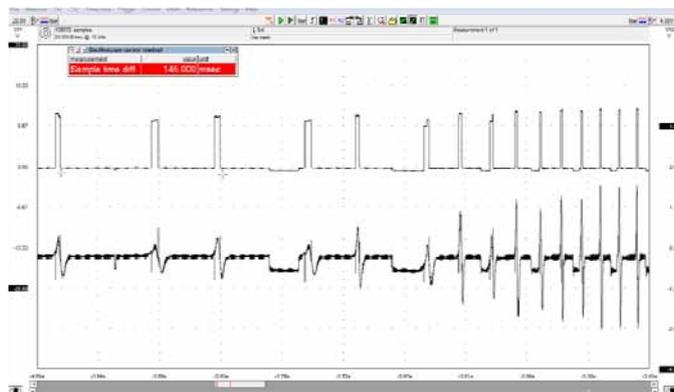
Zoomed in recording of the same crank shaft sensor and RPM signal to the EDU when the engine just fires up. The dips in the signals are where the spill valve loads up the circuit with 17 Amps (!)

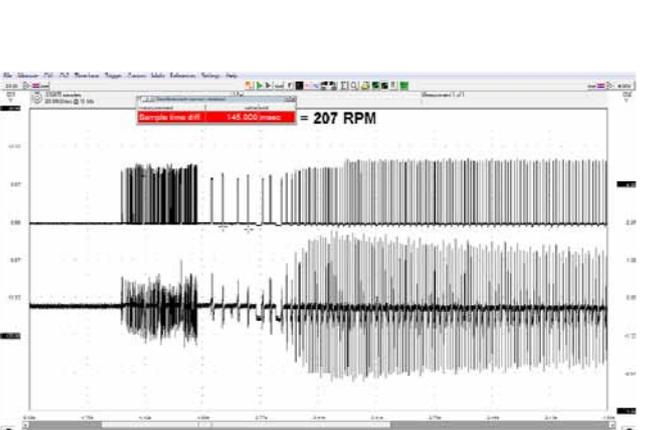
Dual channel ATS 5000 scope recording of the crank shaft sensor and its converted signal when the engine decided to fire up. Look at the mess during winding over!

The signal of the inductive crank shaft sensor (CH2) gets converted in the ECU by a comparator circuit into a square wave. The comparator will switch the output voltage to high when the input moves over an 'arm' voltage level. It will switch its output voltage down to low again when the input

drops below a 'fire' voltage.

The ECU output signal is used by the EDU to see if the crankshaft and pump shaft are in phase (injection timing control).

The 'noise' during start up causes the EDU to receive information that the crankshaft is turning way too fast!

As a result it will hold back Diesel and throws several fault codes, one of them being an ECU error as the CAN bus data reports a different engine speed as the direct RPM signal.

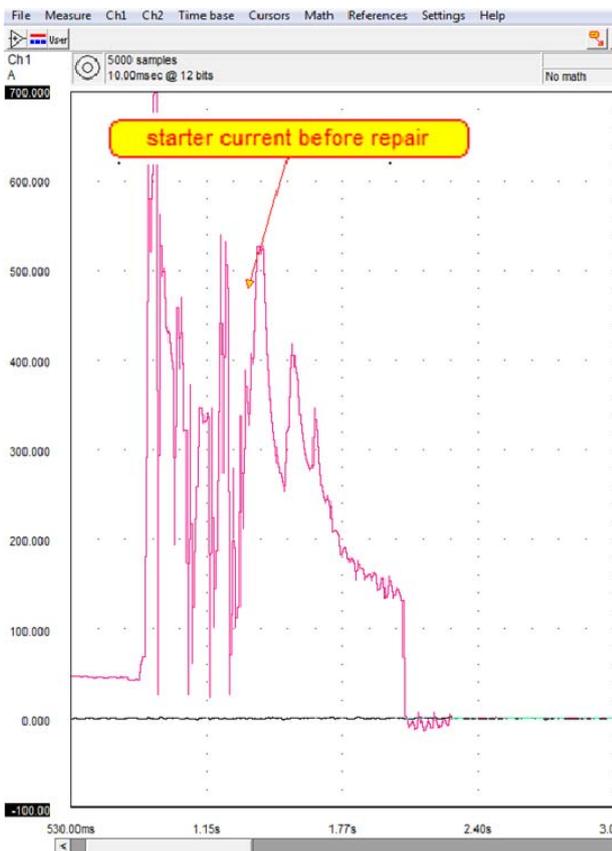
Starter current measurement before the repair. Pls note that the current drops down to almost zero amps about 4 times before it starts to wind over properly.

Sudden current changes create massive changing magnetic fields, which induce voltages into any circuit close by. The greater the current changes, the stronger the induced magnetic fields.

The starter motor current dropped in the above sample 4 times from about 400 Amps to zero

amps and up again! That is massive current changes, the technician had found the problem alright!

The power to the starter solenoid was found to be low, causing the solenoid to cut in and out a few times under high current draw conditions (lower battery voltage). The bad connection in this circuit was by-passed with a relay feeding the starter solenoid directly from the battery positive. This fixed the problem.

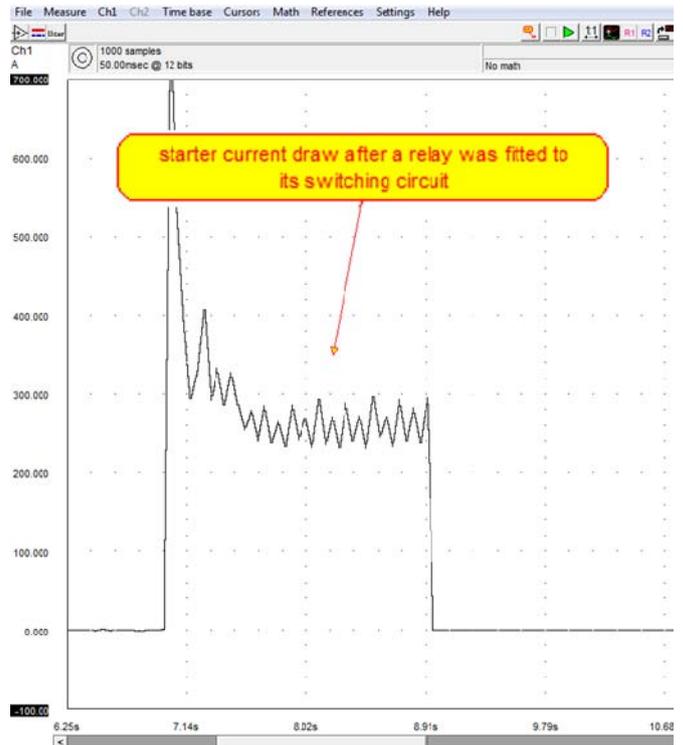
Starter current after the repair.

The start current looks normal after the repair, a high 'short circuit' current (700+ amps) and after the engine starts to turn the starter motor settles on around 250 amps, till the engine fires up.

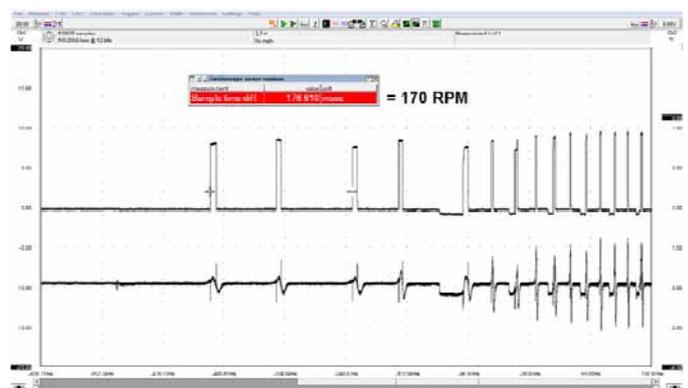
ATS 5000 recording of the RPM signal and the crank shaft sensor after the repair

Please note in both patterns that the cranking speed is almost the same as on the previous recording. This explains why the technicians involved in this job never heard anything wrong with the starter motor or its circuit.
