Grand Elgrand

This article is a true description of an AECS technical help desk problem and how it was solved.

2003 Nissan Elgrand 3.5 Ltr V6 Petrol A/T.

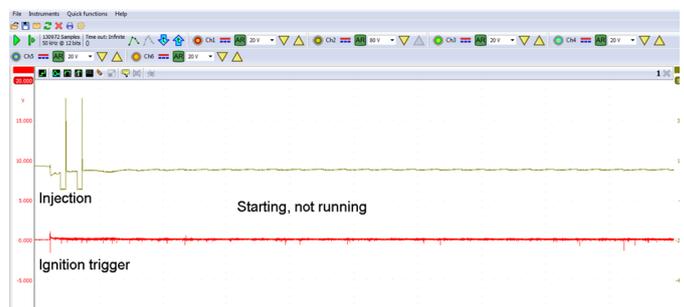
ATS scope recording of ignition trigger vs. injection while winding over.

We had no ignition trigger and a couple of injection pulses. To us at the help desk it looked like a clear crankshaft or crank/cam shaft sensor issue. It seems as if the ECU dumped some start fuel and then continued waiting for a proper crank position.

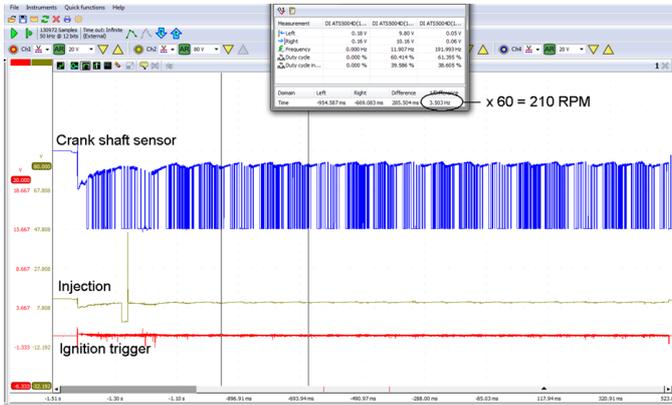
ATS 4 channel scope recording of crank sensor vs. injection and ignition

Again, no ignition and only one injection pulse. We had to look at the crankshaft pattern in detail. It always helps to knowingly look at one full crankshaft revolution or else it can be very hard to look at a repetitive pattern finding irregularities. We placed the cross hairs so that they lined up with approx. 3 dips in the crankshaft sensor signal; this represents the starter motor fighting 3 compressions (pulling battery voltage down). Three compressions equals one revolution on this 6 cylinder engine. To double check, the frequency in the 'value window' on the screen indicates a crank speed of 210 RPM, which is normal start speed.

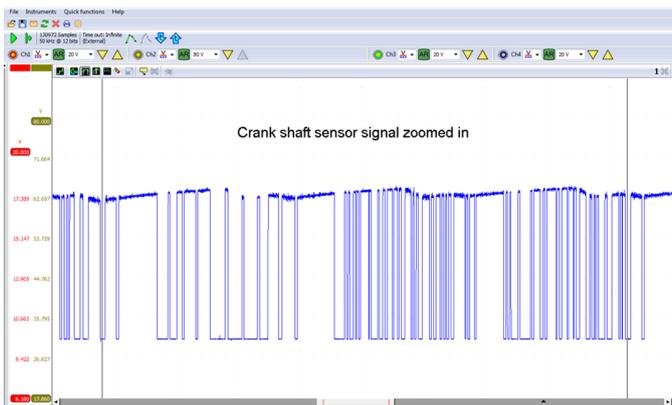
Zoomed in on the crankshaft sensor pattern section between the cross hairs.

We started doubting if we were connected to the correct wires and if we measured at the correct sample speed, as this is a very irregular pattern. We have never seen a good running Nissan producing a signal like this. However, I have dealt with some 'strange' Nissan Hall-effect sensor signals before. In all cases, the magnetic balance of the sensor was disturbed by removing steel brackets, leaving bell-housing bolts out etc. I have even published an article about one some time ago (see www.aecs.net/techsupport).

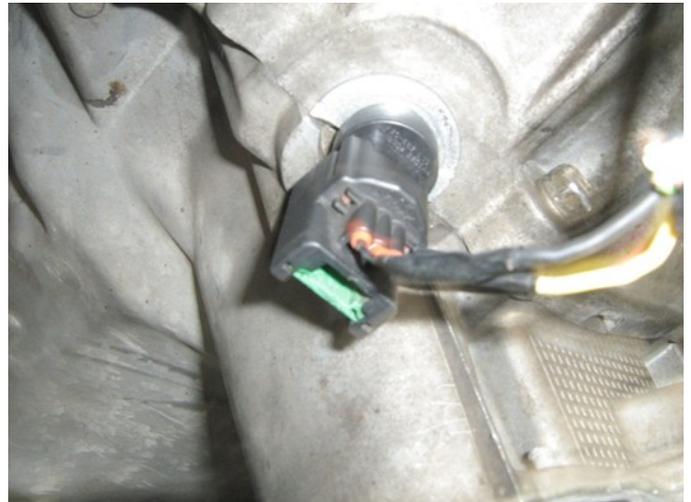
By just looking at the plastic sensor and the aluminium bell housing it looked like a cage was missing, a steel cage that alters the magnetic field of the sensor. Often placing anything of steel attached to earth close to the sensor will overcome that problem. We placed part of a washer around the sensor. The ins and outs of this are dealt with in the AECS AED training.

Half washer fitted around crank sensor

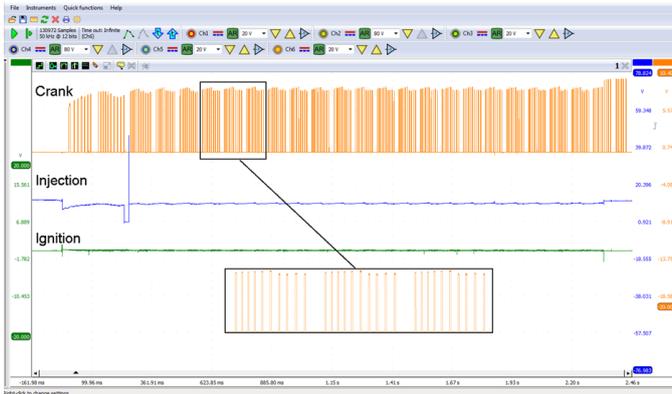
The washer fitted, created a beautiful crankshaft pattern, but the engine still would not go!
We still had exactly the same ignition and injection pattern but the crankshaft pattern was fine.

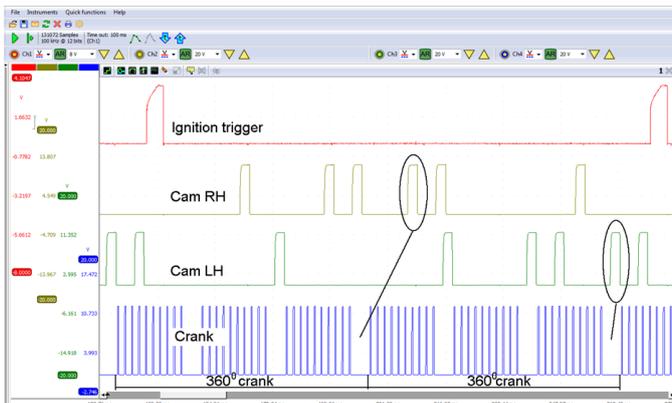
We recorded the crankshaft and both camshaft sensor and found that the RH cam sensor pattern was NOT 360 crankshaft degrees out of phase with the LH cam sensor pattern.

We looked at the pattern in detail and noted that the RH sensor did not switch at logic crankshaft positions. The LH sensor made more sense. We disconnected the RH sensor and started the engine.

Ignition trigger, RH cam, LH cam and crank recording zoomed to 2 revolutions. Please look at cam off set difference.

Yes, that started the engine for the first time in many months! It took a while before it fired, but it went. The pattern recorded is after the engine started. While running we plugged the cam sensor in to have a nice clean signal of a stable running engine. This made it easier to see the phase offset.

It was now obvious why the engine was not firing up; two problems, the crankshaft signal, and the

camshaft sensor signal were both incorrect, getting the ECU into calculation trouble.

wheel has to be repositioned on the cam shaft, which means engine removal (3rd time!!!).

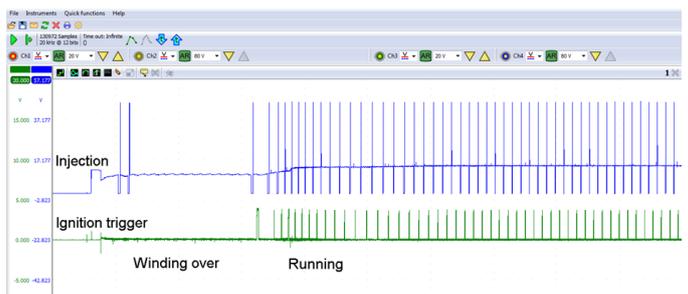
It was still hard to start as the ECU was waiting for the RH sensor signal but after a few revolutions, it would go into limp home and would fire up anyway.

Injection vs. ignition after steel washer placed and RH camshaft sensor disconnected.

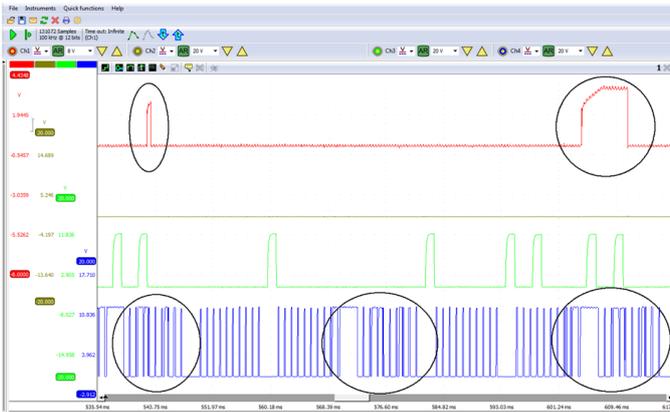
With the washer removed from the crank sensor and the RH camshaft sensor disconnected, the engine would run briefly and stall during our first attempt, later it would not start at all. We recorded the crankshaft, camshaft and ignition trigger pattern and zoomed in to just before the engine stalled. The crankshaft sensor is back to being irregular.

Ignition trigger vs LHcam vs crank shaft sensor with the washer removed, just before stall.
Please note the RH cam sensor is disconnected to make the engine start.

With the washer back around the sensor, the engine would run beautiful again.
