# Closed Loop Common Rail.

**This article is a true description of an AECS technical help desk call.**

Problem presented to the help desk a **2008 Nissan Vanette CR diesel** with a misfire at about 1300-1500 RPM. This article is complex and needs detailed reading for full understanding, enjoy!

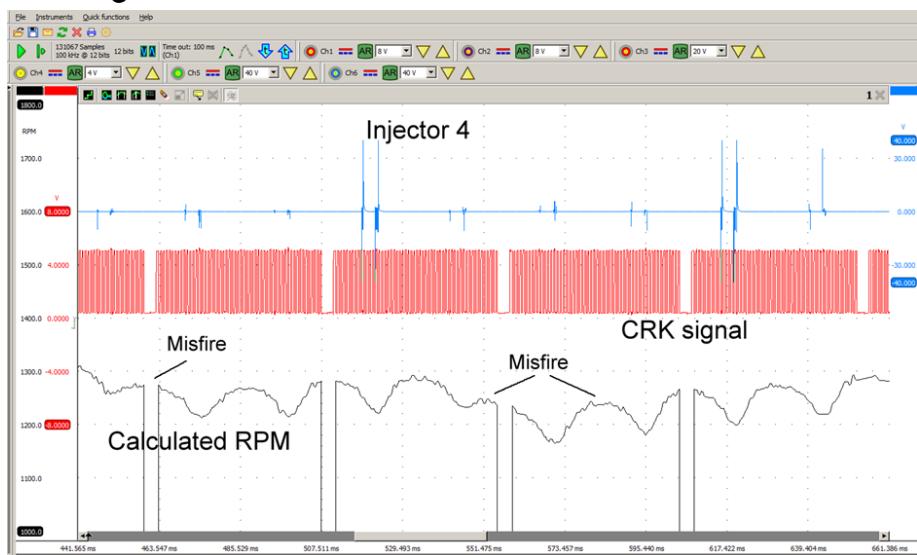
Zooming in on the crankshaft pattern showed that there is no noise on the pattern so this will not be the cause of the misfire.

Figure 1: ATS scope recording of crank vs injection showing misfires.

The recording of crank vs. injection with the calculated RPM line shows that there are multiple misfires occurring which seem to be linked to two cylinders. Based on the firing order we can see that cylinders 1 and 2 are missing.

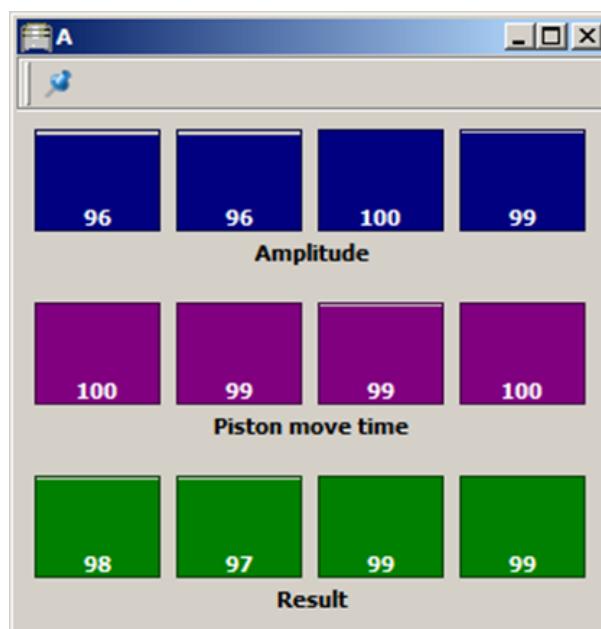
We can now safely say that the EGR is not the cause for the misfiring engine and that we are happy with the gas flow through the engine. Just to be doubly sure a relative compression test was also performed which showed that all four cylinders were within two percent of each other, a perfect result.

Figure 2: relative compression test

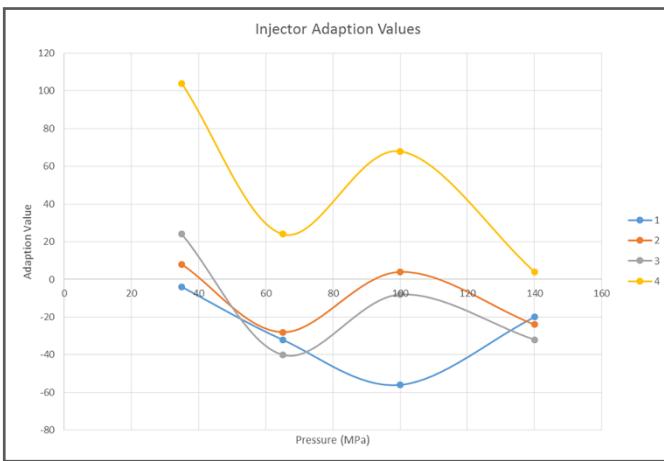
Figure 3: injector set-points and adaption values.

Figure 3 shows the four set-points at 35, 65, 100 and 140 MPa rail pressure. This graph instantly shows that there is an issue with injector number four because its adaption values lie so much higher than the other three injectors. However, our crankshaft speed measurement did not identify #4 as a missing cylinder.

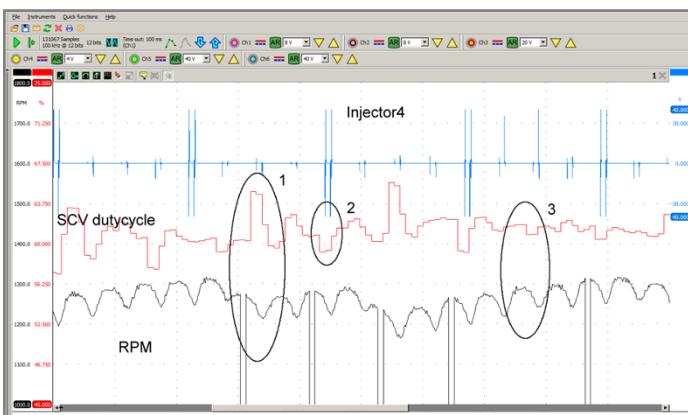
Figure 4: ATS 5004d scope recording of inj, SCV duty cycle and RPM.

When the suction control valve duty-cycle increases, more fuel enters the rail, when the control valve duty-cycle decreases less fuel enters the rail. Figure 4 highlights three important areas.

**#1.** The duty-cycle increases after a misfire has occurred. The ECU sees that the crankshaft has slowed down and now wants to speed up the crankshaft again. This is done by injecting more fuel in the following cylinder.

**#2.** The duty-cycle decreases after injector four injects. This is because injector four has higher than normal leakage rate (see test sheet table).

**#3.** this is the same cylinder as in #1 but now we don't see the increase in duty-cycle. This is because the cylinder beforehand fired properly so there is no need to speed up the crankshaft with additional fuel.

In this duty-cycle pattern, we can see two mechanisms at work. We can see the ECU compensating for a sudden decrease in crankshaft speed and we can see the ECU compensating for an injector with high return flow (rail pressure decrease).

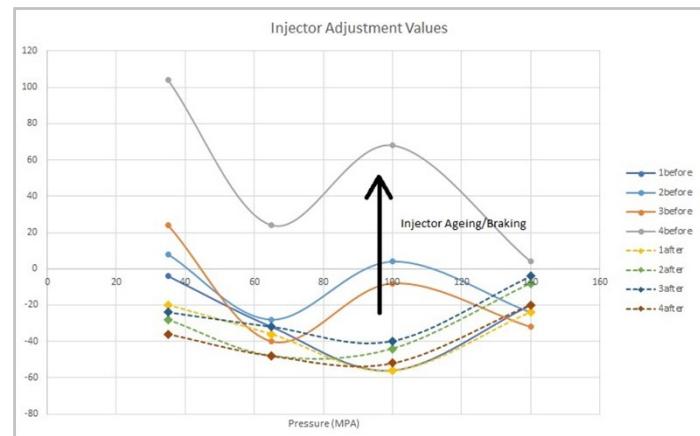
have the injector compensation values re-checked. Figure 5 below shows the before and after results. We can see that Injector one did not need replacing because the compensation values did not move as far as the other three injectors.

**Figure 5: before and after replacement injector compensation results.**

As a result, **we replaced all four injectors**. The car was returned to the customer who took it for a 1000km drive and then bought it back into the workshop to
