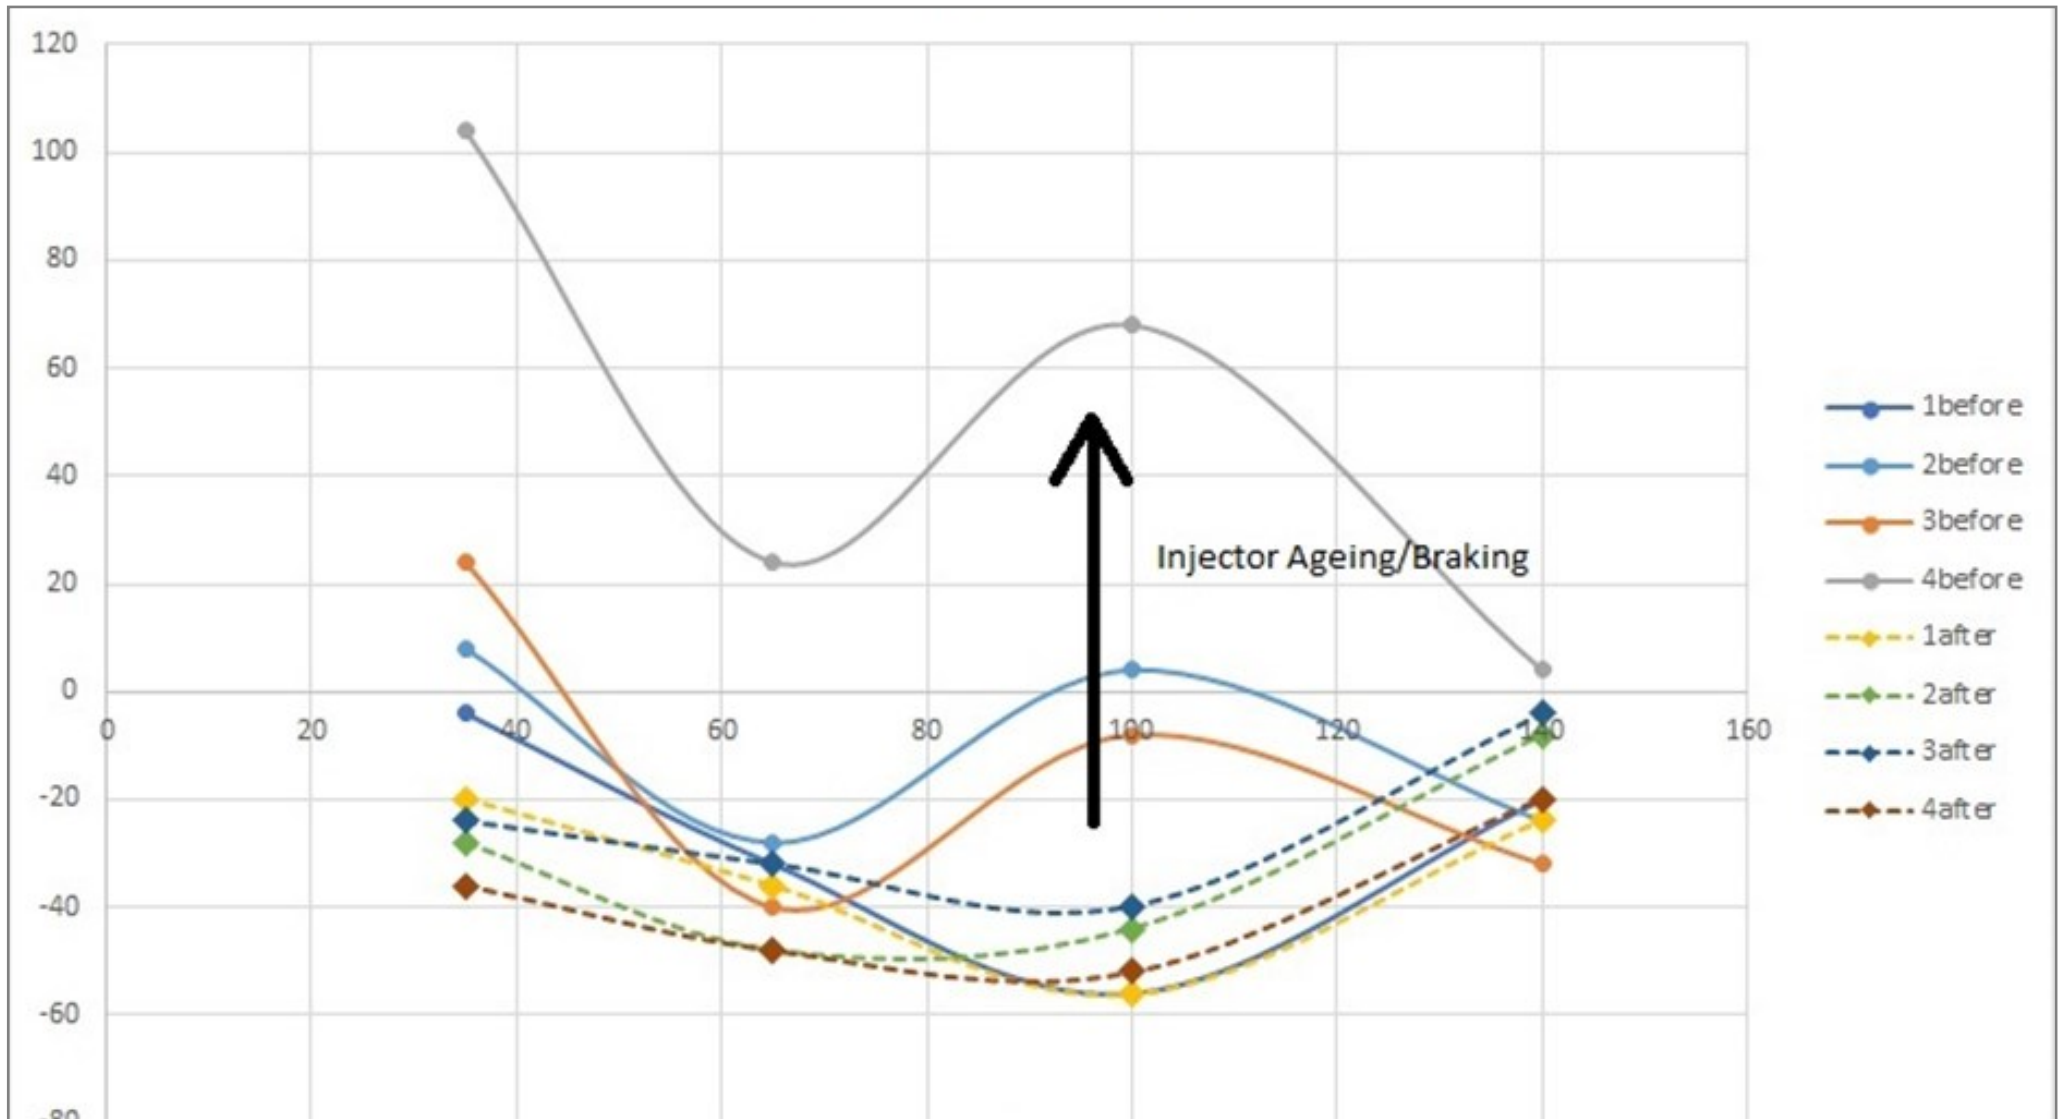
Figure 5: before and after replacement injector compensation results.
