Sly Sylphy

Vehicle
 2002 Nissan Sylphy (Bluebird) 2.0 Ltr direct injected.
 (QR20 (DD) Engine)

Problem presented to the Helpdesk

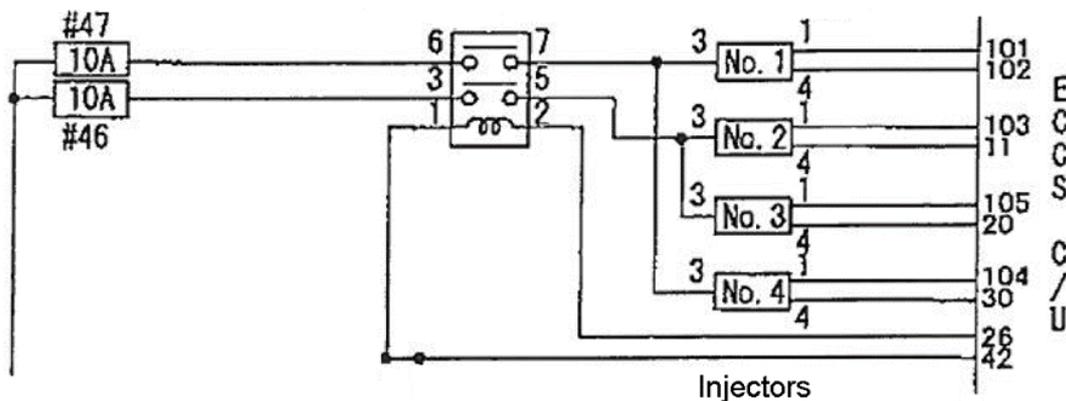
The injectors used in these Nissan engines are of the 3 wire type. As discussed in the EMS 1-3 training, the injectors have 2 coils. One coil with a very low resistance to open the injector very quickly and one 'normal' coil to hold the injector open.

In this wiring diagram, the 4 three wire injectors can be seen.

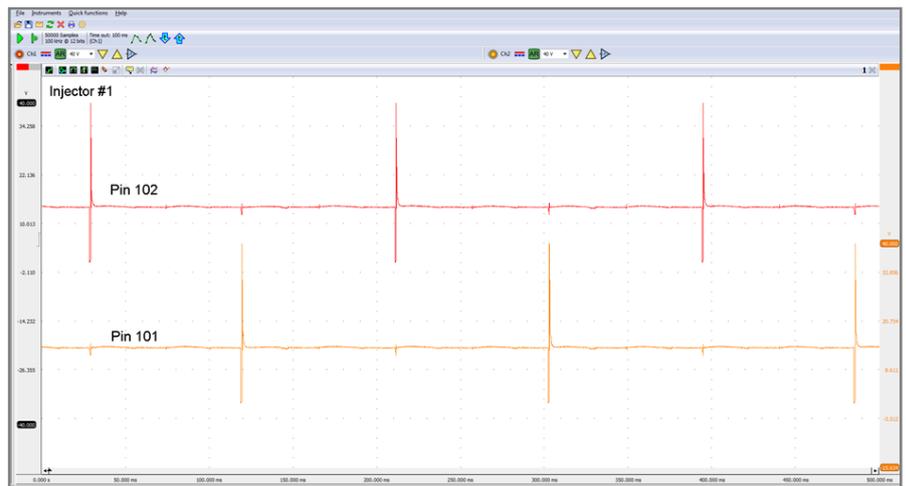
This first measurement (Picture 1) the diagnostician made revealed that the number 1 injector scope pattern looked very different to the rest of the injectors.

The dual channel measurement made with the ATS scope showed immediately that there was a problem with how the ECU was 'driving' the injectors, specifically number one.

Picture 1: ATS scope recording on injector 1

This left us at the AECS helpdesk puzzled. We had never seen that before. Both coils of one injector need to be activated at the same time! Not with a 180 degree offset as recorded at injector #1. This looked to us like as if the ECU was 'confused'. If you combine that with the fault code P0605 (ECM), anyone would start to lean towards a 'magic fault' (=ECU fault).

What the recording did tell us is that the injector #1 was injecting 2 times per 2 revolutions, instead of once. This would certainly make the engine run incorrect to say the least.

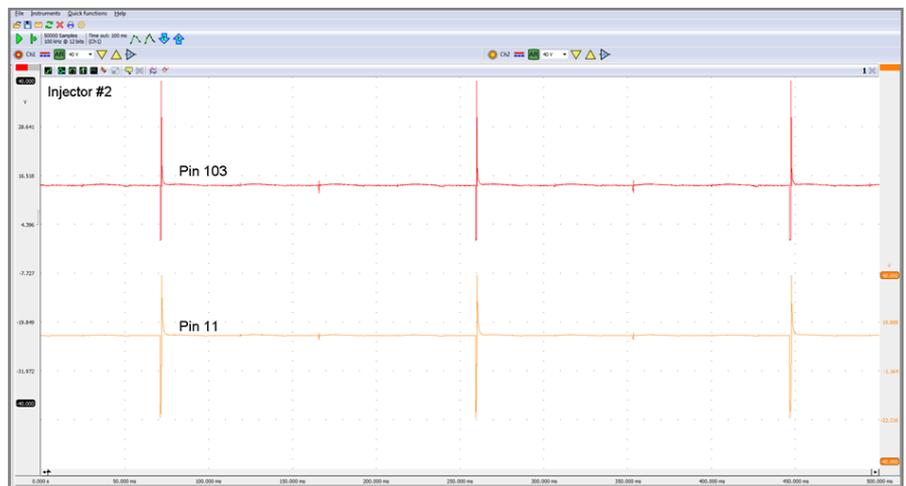
Picture 2 : ATS scope recording on injector 2

The injectors 3 and 4 recording looked the same as the recording on injector #2. (Picture 2)

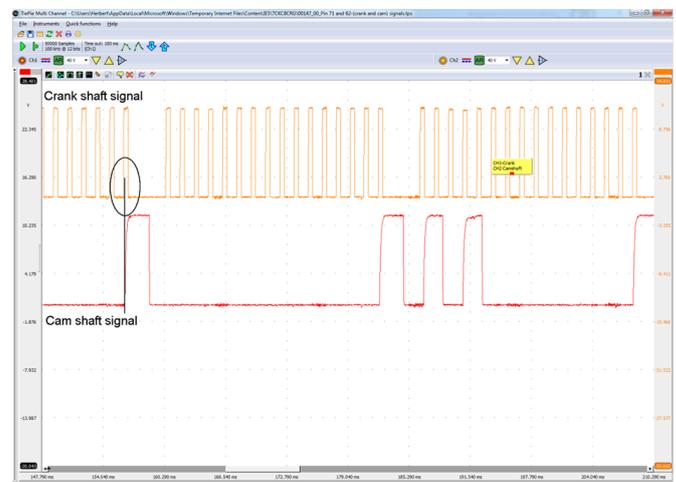
Picture 3 : ATS 5000 scope recording of cam vs crank.

A logical next step is to record cam vs crank signal. (Picture 3)

At first glance, this signal is wrong! The rising slope of the single pulse of the cam should not coincide with the last teeth before the ref point of the crank shaft.

I said without too much further thought that he had to replace his timing chain and guides, and thought that this would be the end of it.

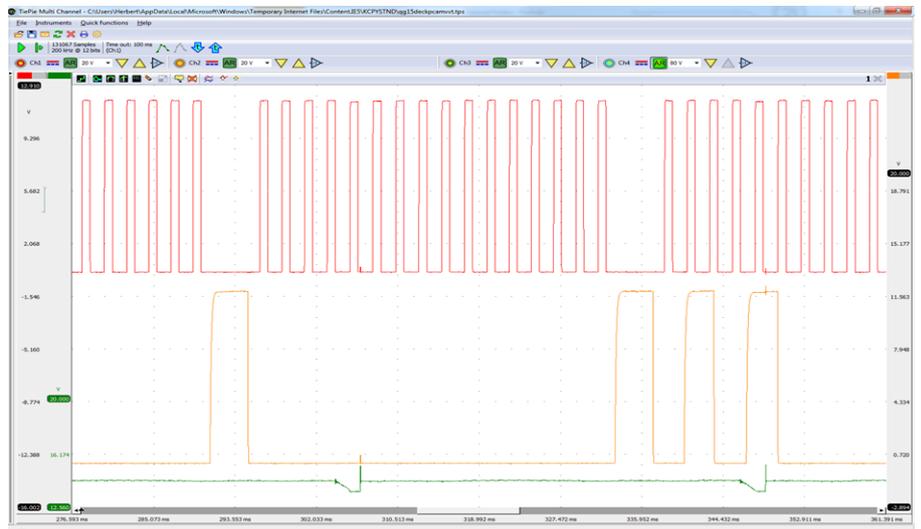
I have seen so many before. However, this seems to always give ignition faults, never seen injection faults like this. To make sure I even looked up a pattern recorded on another Nissan, not a QR20 (DD) Engine. (Picture 4)

Picture 4 : ATS scope recording on a random good Nissan

The compare signals HAVE to be of the same engine.

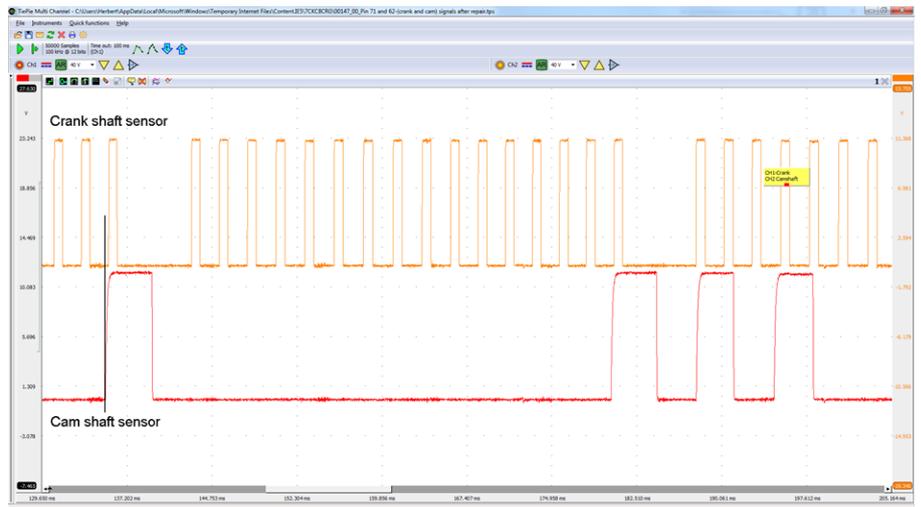
The remark of the diagnostician after the cam chain replacement job was; "it runs sweet but the cam crank pattern is very different from what I expected"

Of course, when I saw the pattern, (Picture 5) we disrespectfully asked the diagnostician "are you sure the marks line up?" However, even before the question was expressed we realised that the cam had to advance with new chain and guides, something it obviously did.

Picture 5 : ATS scope recording of cam vs crank after repair.

The car is fixed, it runs perfectly now. No more fault codes. Yes, the problem was the timing chain and not the ECU. However, this case has taught us here at the AECS helpdesk that we have to be more careful with comparing known good patterns with problem patterns, no complacency allowed!
