# AECSTechnical Article ~ Gappy Golf

**Vehicle:** VW Golf Mk4 2000 1.8Ltr 20 Valve AGN Jap import.

## Problem presented to the help desk

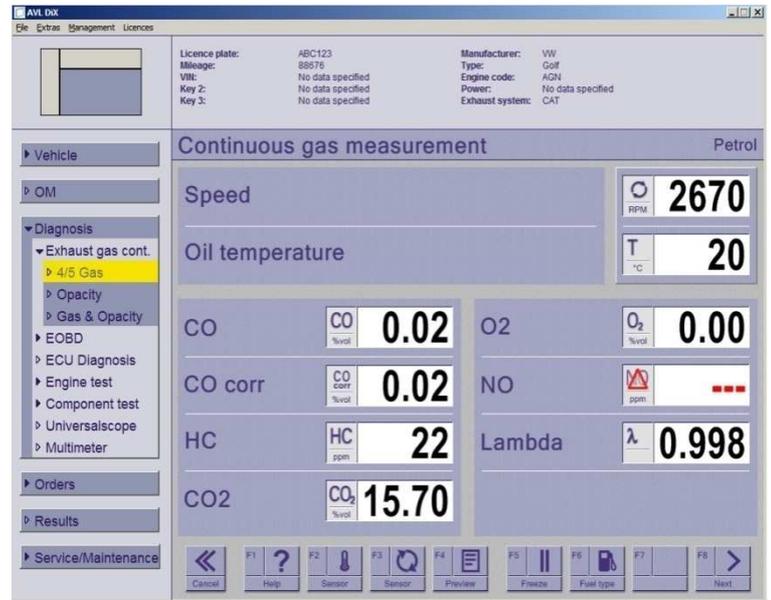
Figure 4 High idle emissions measured with the AVL DiGas 480.

Again absolutely beautiful results! It is obvious that the Catalyst is working well even at higher exhaust gas flow rates, and the small fluctuations of the Lambda figure around 1.00 indicate a fine working oxygen sensor. If you have to try to find something wrong then the HC's are again a little elevated, but nothing to worry about, certainly no indicator that work needs to be done.

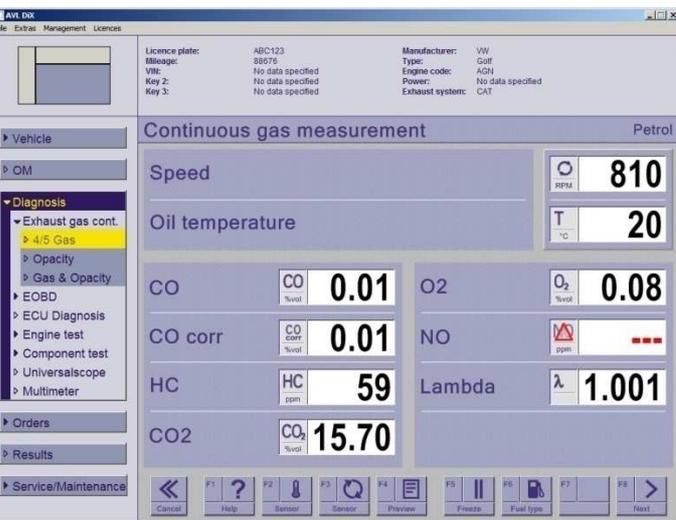
Figure 3 Idle emissions as measured with the AVL DiGas 480.

I really like these emissions, very high CO<sub>2</sub>, very low CO, very low O<sub>2</sub> and a Lambda of just a nudge over 1.00. The only small reservation I have is the level of HC's. All it shows is a good working catalyst and a good working Oxygen (Lambda) sensor. The slightly raised HC's could be the result of for example injector wear/contamination, raised EGR, poor ignition, intake manifold contamination (disturbing the airflow), oil vapour, etc. Nothing shocking, don't get me wrong.

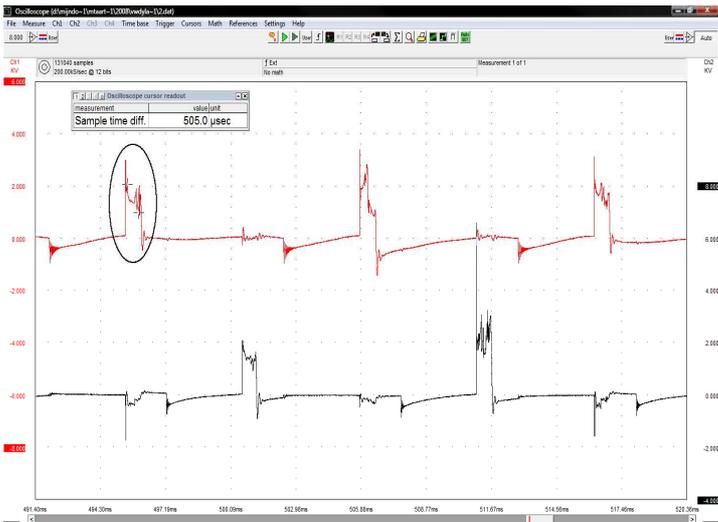
Figure 5 Secondary ignition measurement on both DIS coils.

Instantly it becomes obvious that the spark duration is not long enough!

The short spark duration could be the result of bad primary connections, a damaged coil/ignitor or worn sparkplugs.

The sparkplugs were replaced during the full service 12,000 km's ago (so the customer said), so it is possible that they are worn. For sure is that a short spark duration will create misfire under load. This could be the 'flat spotting' the customer was talking about.

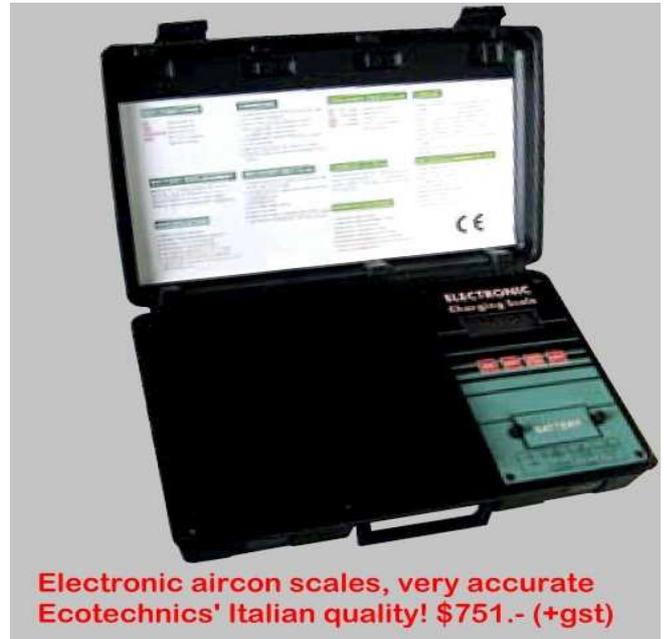
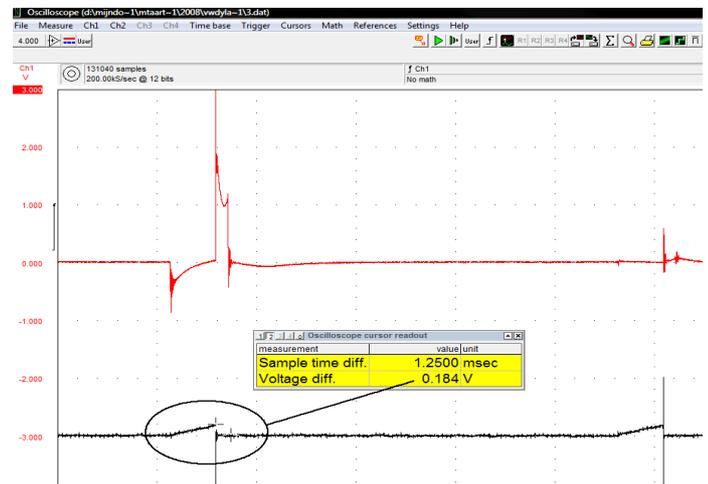
Figure 6 ATS 5000 Dual channel secondary vs ignitor earth measurement.

Earth Loss on CH2 indicates a minor 0.184V loss. Nothing to worry about!

The power supply indicated 0.92V loss which is a little on the high side, but not enough to drop the spark duration down to less than half of what it should be.

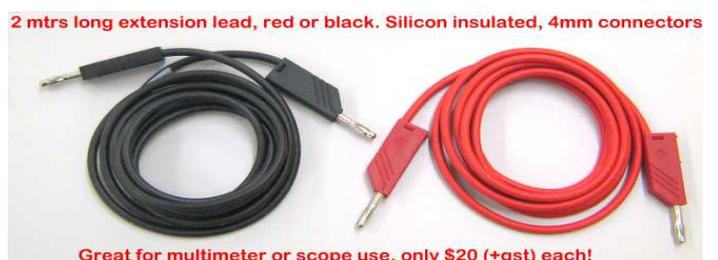
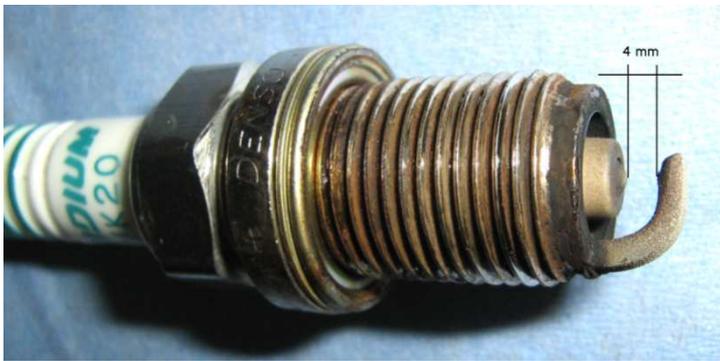
**Figure 7** The fine iridium tip of the positive sparkplugs had completely burned away.

Too easy! The fine iridium tip of the positive sparkplugs had completely burned away. The arc plate on the negative plugs was also completely burned away!

Iridium plugs are long life plugs, I guessed that the approx. 4 mm gap on this (non genuine) plug was the result of at least 100,000 km's or so. That on a 88,000 km vehicle.... I wondered what happened here!

After the proper VW triple electrode spark plugs were fitted the spark time was beautiful, and the car was running without any problems.

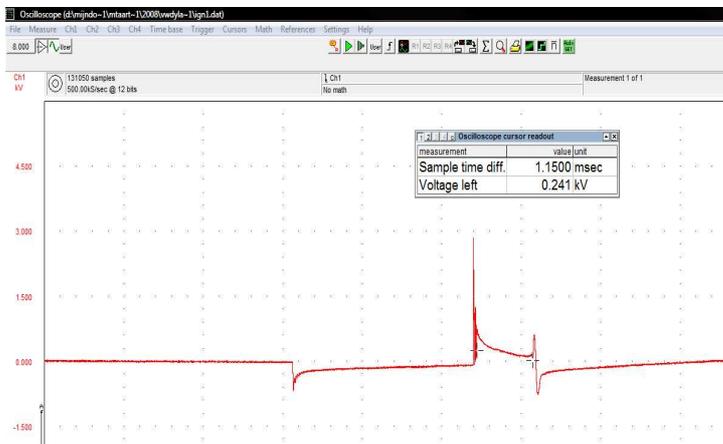
**Figure 8** Ignition measurement after sparkplugs had been replaced.
