# AECS Technical Article ~ Low Tension High Tension

**Vehicle:** Subaru Legacy 1997 EJ20, with quad coil ignition system.

**Problem presented to the help desk:** The car offered for repair has a high tension misfire, every time when accelerating it is misfiring, only really gently easing the throttle down increases the revs.

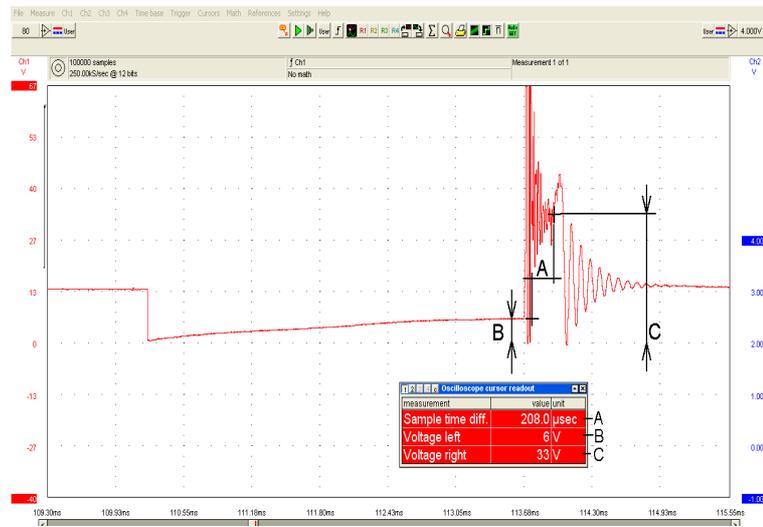
The ignition primary revealed the following real big concerns.

- The spark duration was far too short for an idling engine with no load. The 208 µsec (0.2msec) shows up as a good spark if held on the rocker cover. In the combustion chamber it produces a tiny non sustainable flame, which is 'blown out' when you increase the air in the combustion chamber by opening the throttle.
- The voltage loss on the negative side of the coil was a phenomenal 6 (!) Volts.
- The spark voltage on the primary showed that the sparkplug gap was on the small side, the 33 volt is on the low side.

We must increase the spark duration and sparkplug gap so that a good sustainable flame is being created in the combustion chamber, one which does not get blown during acceleration.

The spark duration can be increased by fixing the primary voltage losses which are restricting the current flow through the coil. The restriction of current in the coil results in a weak magnetic field in the coil. Only a strong magnetic field in the coil's iron core can create a strong spark.

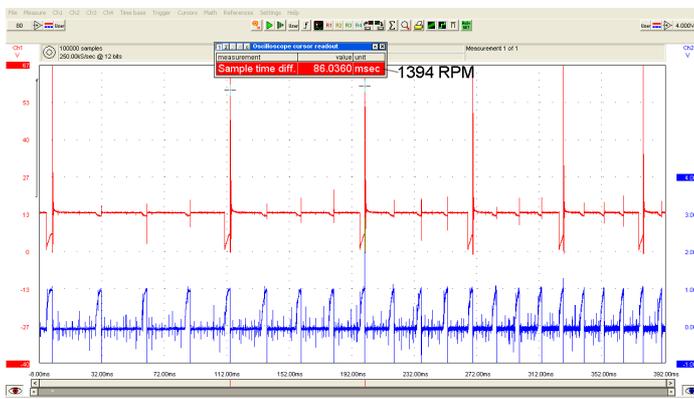
ATS 5000 dual channel measurement of coil primary and ignitor earth while accelerating

The earth wire of the ignitor should be zero volts, there is at least one volt loss.

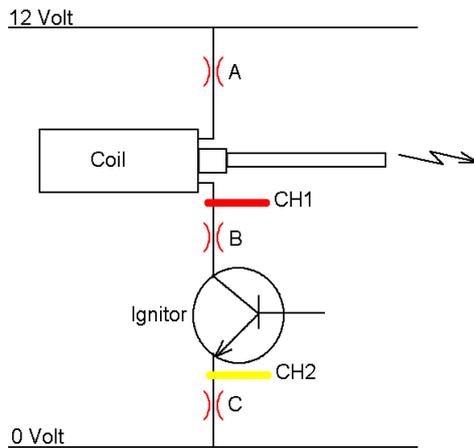
Simple depiction of coil and ignitor wiring and where the 2 channels of the scope were connected to

As you can see in the above schematic, the channel 1 lead is connected to the coil's negative side, and channel 2 is connected to the ignitor's 5<sup>th</sup> wire which is its earth connection.

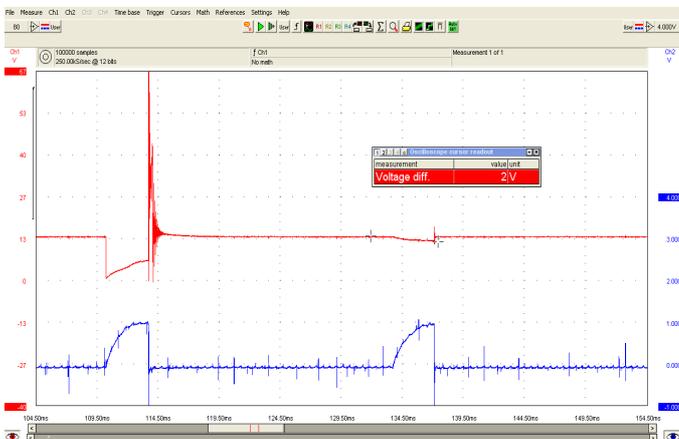
It is clear to see that the other coils during activation 'pull' the power supply an enormous 2 volts down, on the measured coil this is at least the same if not more!

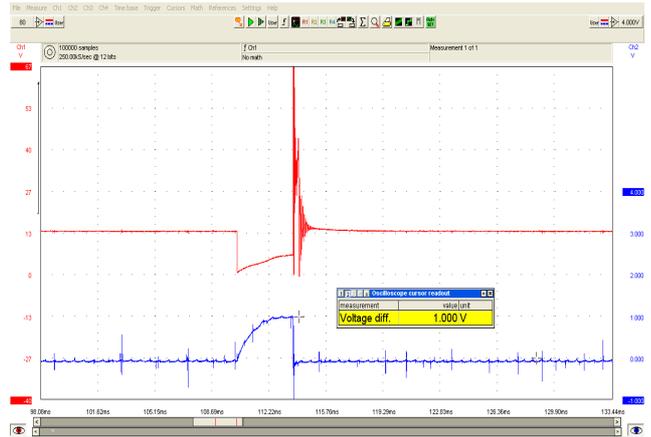
We are losing 1 volt on the ignitor's earth wire. Let's look at the wiring diagram again and put all the losses into perspective:

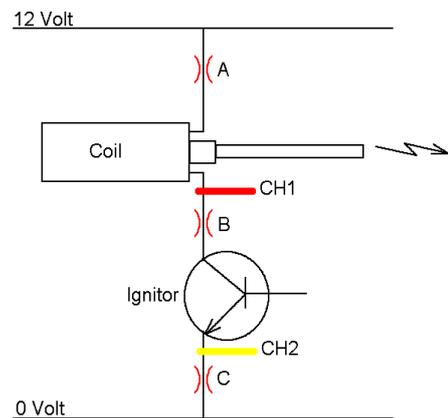
- Bad connection A: 2 Volt
- Bad connection B: 5 Volt\*
- Bad connection C: 1 Volt

This equals a whopping 8 volt loss in the primary circuit!

\*) bad connection B & C plus the loss in the ignitor add up to 6 Volts.

Don't stare at it, just fix it. Pulling new wires and increasing the sparkplug gap made this car run like a beauty again.
