Poddy Mitsi

This article is a true description of an AECS technical help desk problem and how it was solved.

1997 Mitsubishi Legnum VR4 6A13 (V6 Turbo).

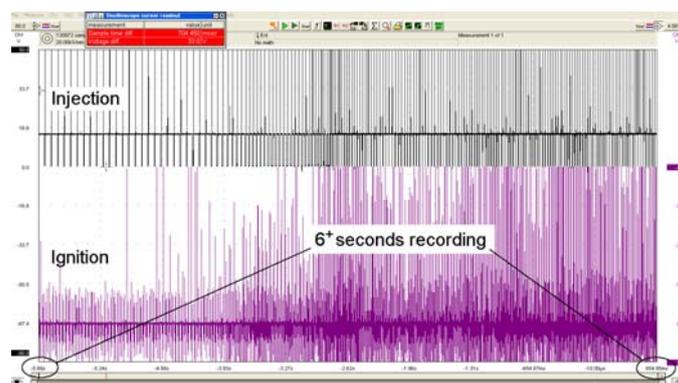
Figure 1: *ATS 5000 dual channel scope recording of Injection over ignition. The remote 'store' button was pressed around 2 seconds after the fault occurred, giving the diagnostician a view of what happened before the fault, during the fault and after.*

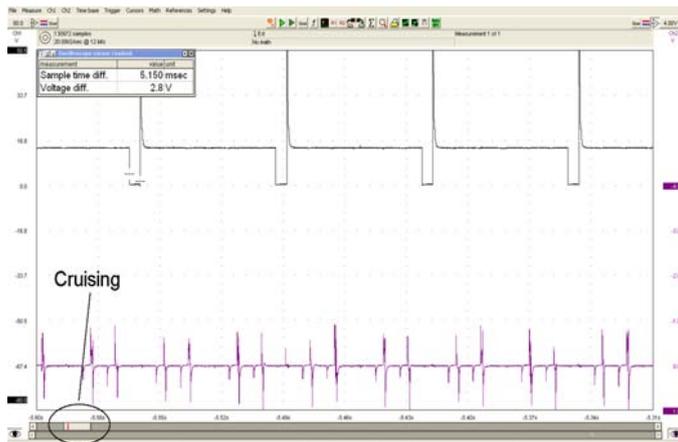
Figure 2: Scope recording zoomed in on phase where everything is 'normal'. Please note the 5.1 msec injection duration. The 0.9 msec ignition duration is short and deserves attention, but lets first examine the whole recording.

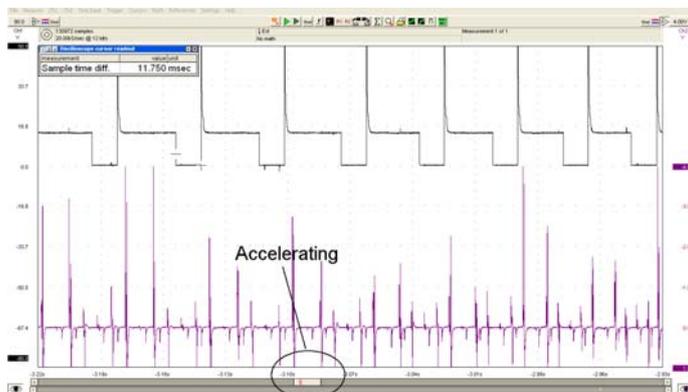
Figure 3: The same scope recording, scrolled to the point where it is clear that acceleration takes place. Please take note of the 11.7 msec injection duration.

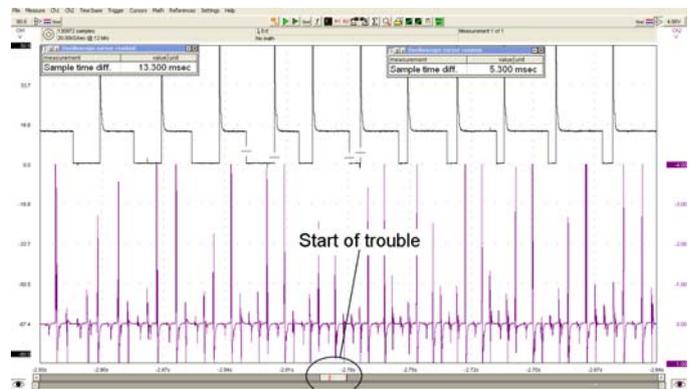
Figure 4: Bingo! the same first scope recording, scrolled to the point where the problem starts. Please note the sudden change in injection pulse width, in two beats it moves from 13.3 msec down to 5.3 msec.

It needs to be noted that the driver was not moving his foot when this happened, He was accelerating firmly but steady.

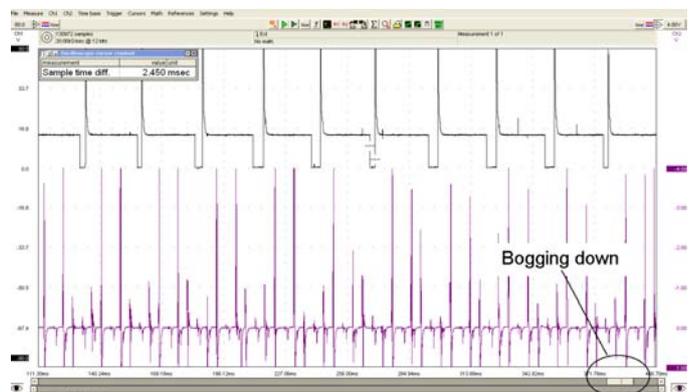
Figure 5: Same recording, and still with the foot firmly on the accelerator. Please note the VERY narrow (2.4 msec) and variable injection pulse width.

This diagnostician knew his stuff, on top of his own experience as an auto electrician he attended almost all of our AECS diagnostic training seminars. The injection pulse width was clearly the problem, the narrow pulse almost stopped fuel from entering into the combustion chamber. He knew that the injection pulse width calculation is only grossly affected by Air mass, TPS and ECT. So let's measure the most important one first, airmass over injection and see if it will happen again.

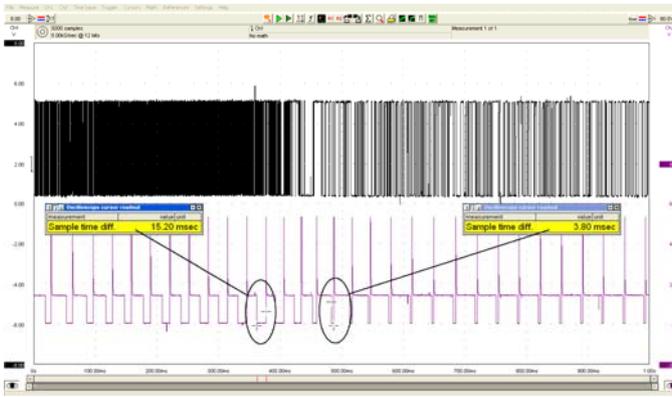
Figure 6: Scope recording of the Karman vortex air-mass sensor signal vs injection.

There it was again, a sudden transition from 15.2 msec to 3.8 msec. Lets zoom in on the pattern and look at the air mass sensor's frequency.

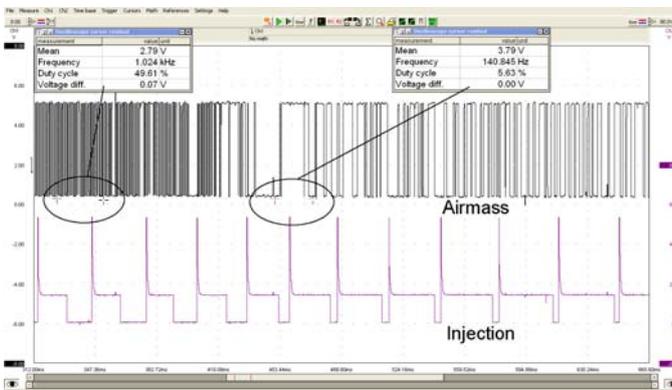
Figure 7: Same ATS scope recording of the airmass sensor signal vs the injector pulse width, focussed on the frequency of the air mass sensor

That is a massive change of air! The frequency indicates to the ECU the quantity of air entering the engine. The frequency dropping from 1024 Hz to 140 Hz will have a massive effect on the injection quantity, as can be seen in the injection pattern.

We now had the cause for the bogging down of the engine.

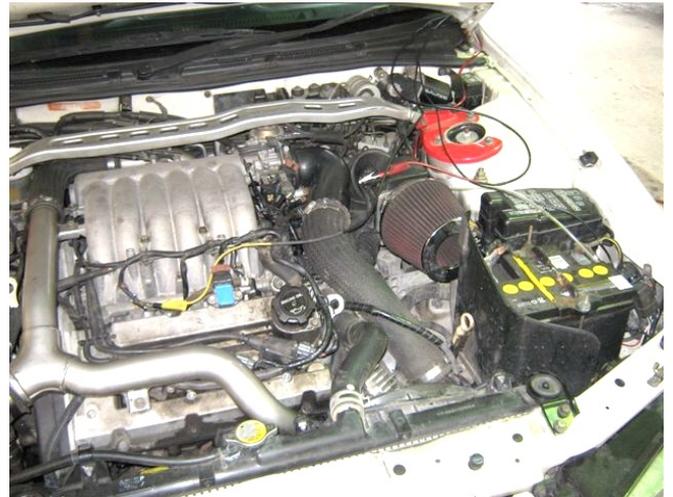
Figure 8: Overview picture; What stands out?

The 'pod' filter! A pod filter DOES disturb the airflow! It needs to be noted that a carman vortex airmass sensor has to have a very stable airflow into the grating upstream of the measuring element. This measuring element measures the vortexes (controlled disturbance of airflow). By fitting a 'pod' filter you disturb the airflow uncontrolled, decreasing the vehicle's performance. But not as much as what we measured, there had to be more.

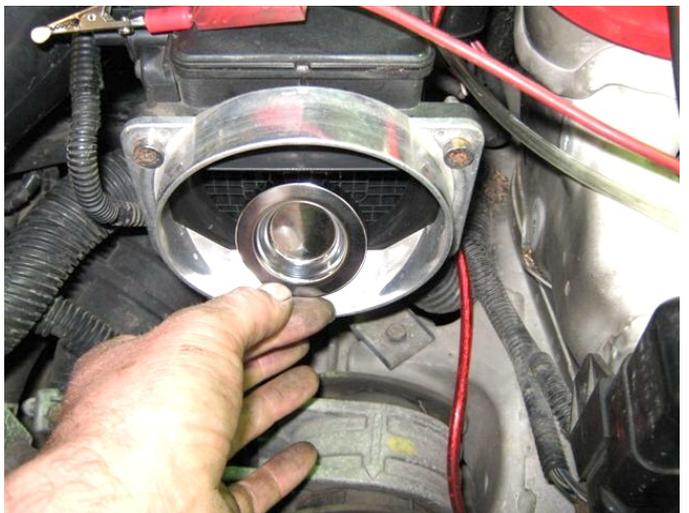
Figure 9: When taking the filter off a shiny disc fell out...

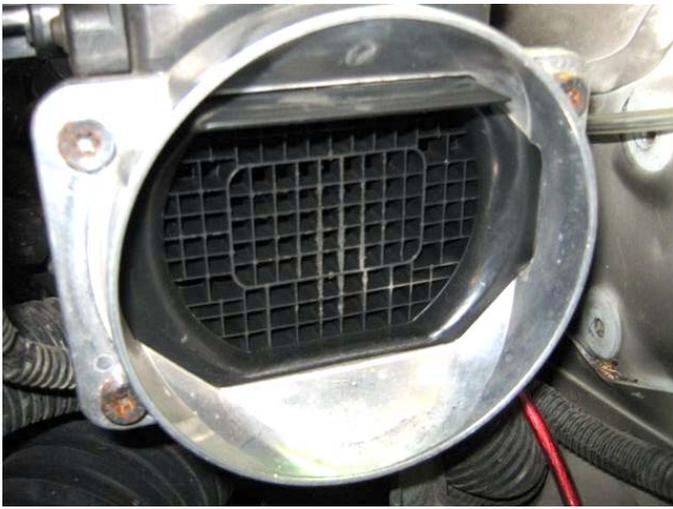
Figure 10: *The shiny disc has damaged the grate, destroying the airmass sensor.*

Good isn't it? Now we had a need for a new air-mass sensor, a new filter and its (original) housing and still maybe a premature worn engine / turbo. And the customer only just bought the vehicle.

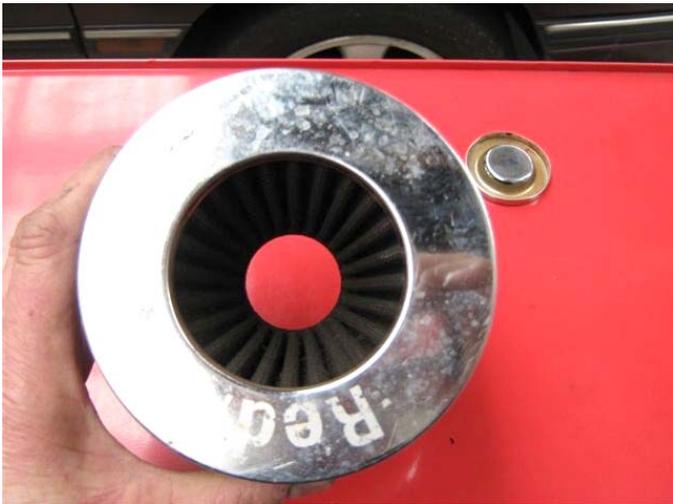
It was not the filter which disturbed the airflow, the filter was not even being used!

The end cap had come off this filter letting unfiltered air into the engine for who knows how long.
