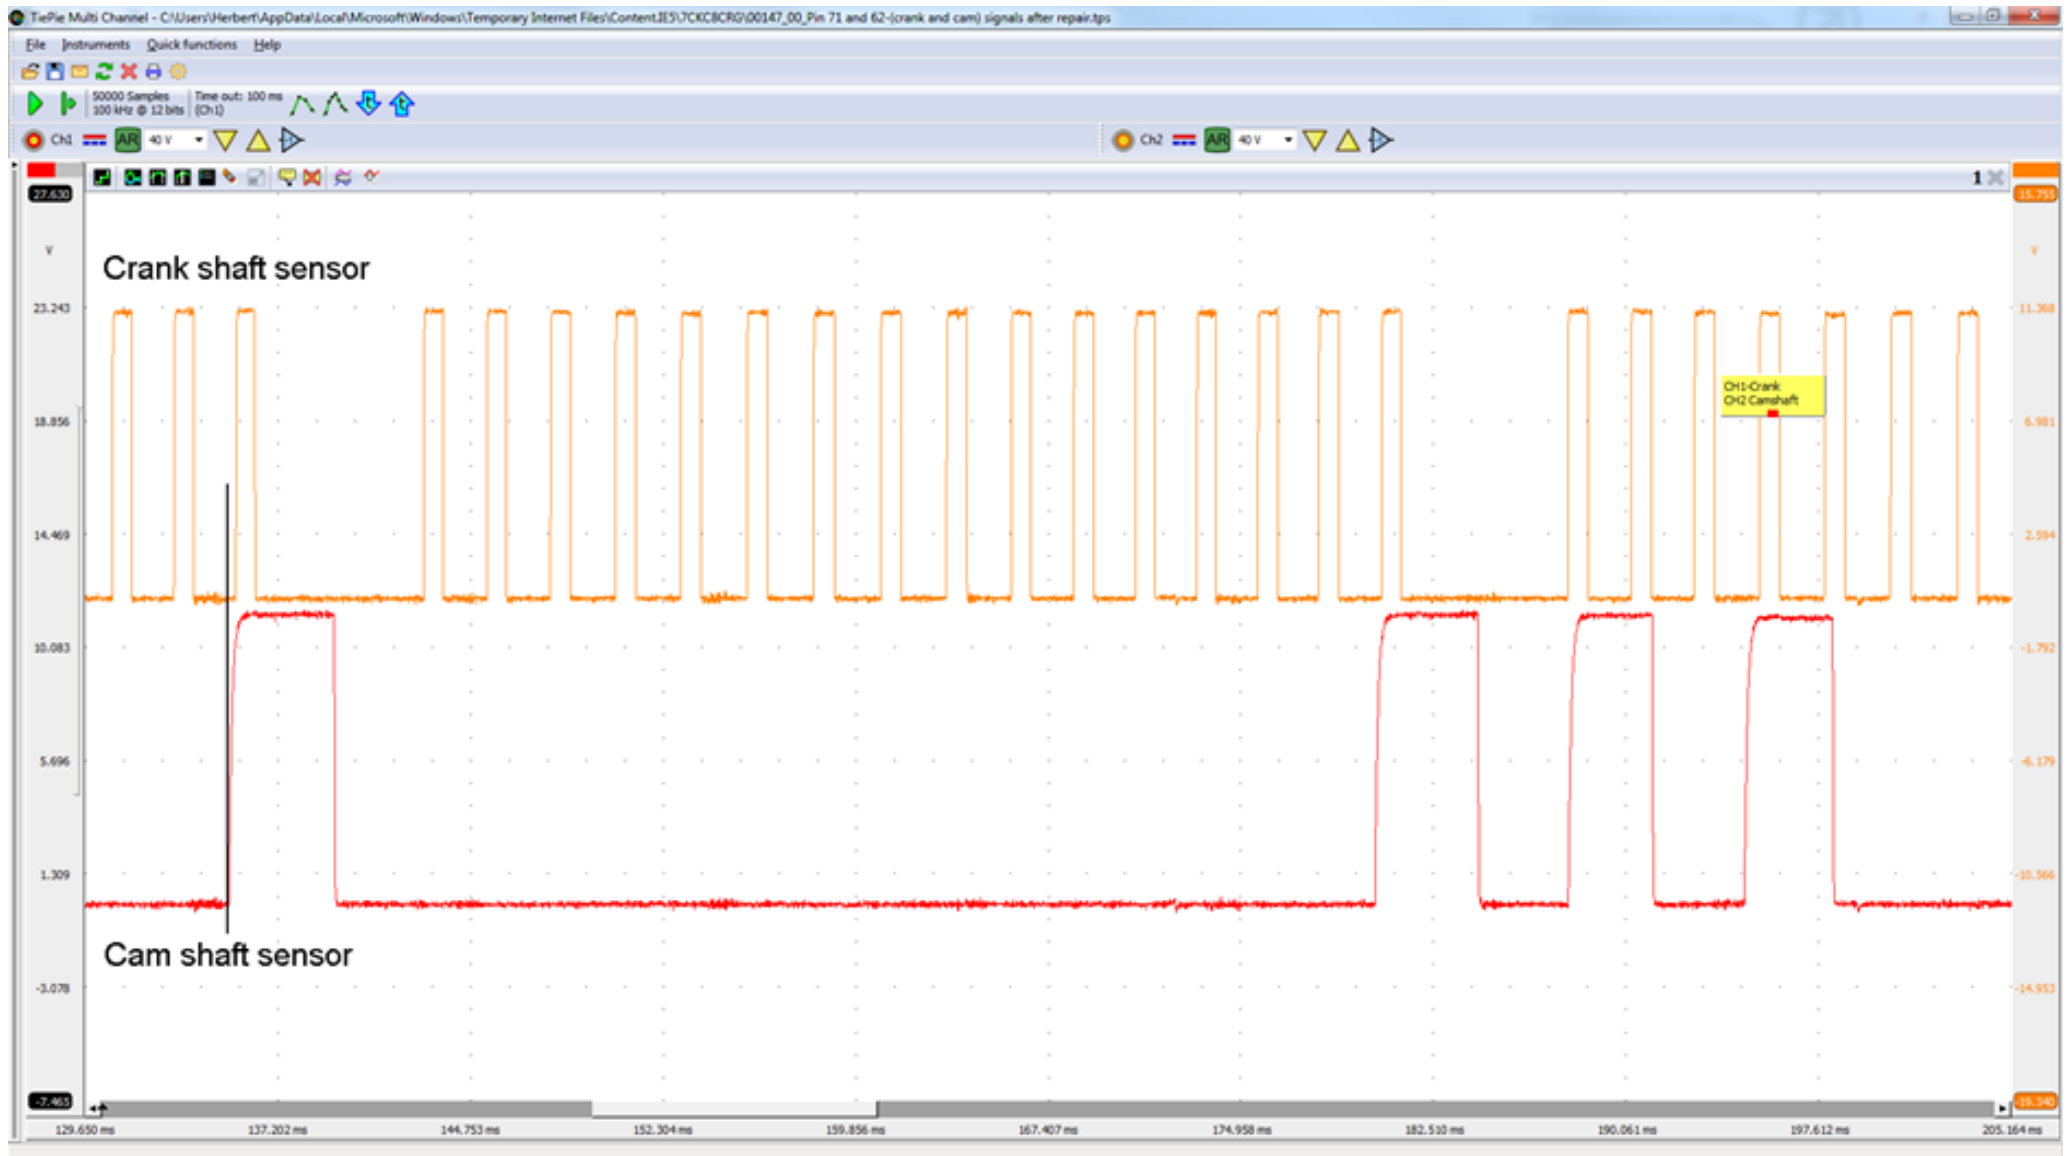
Picture 5 : ATS scope recording of cam vs crank after repair.
