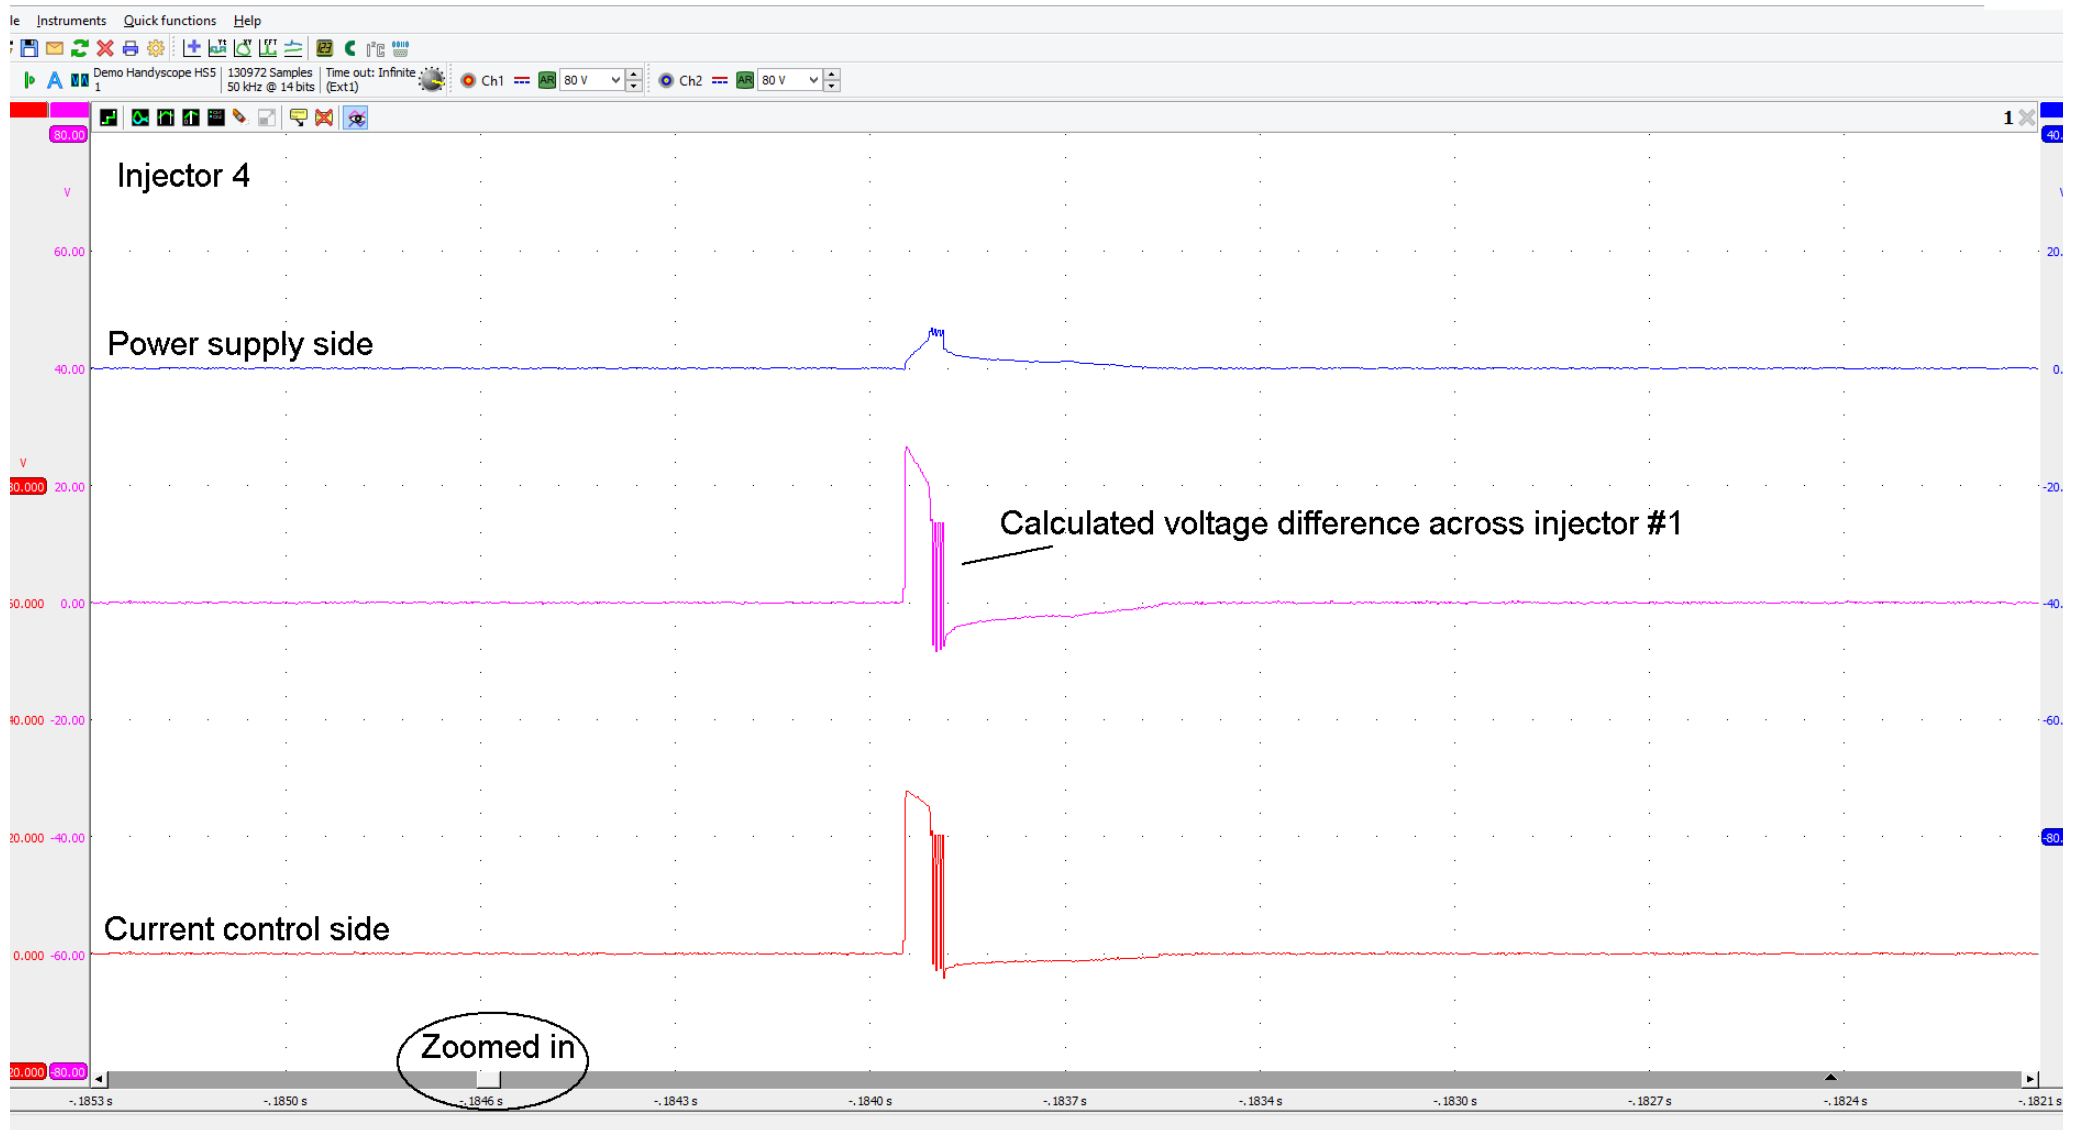
Picture 3: *ATS 500XM scope recording, Ch2 connected to injector #4 (faulty) power supply, and Ch1 connected to the injector current control wire.*
