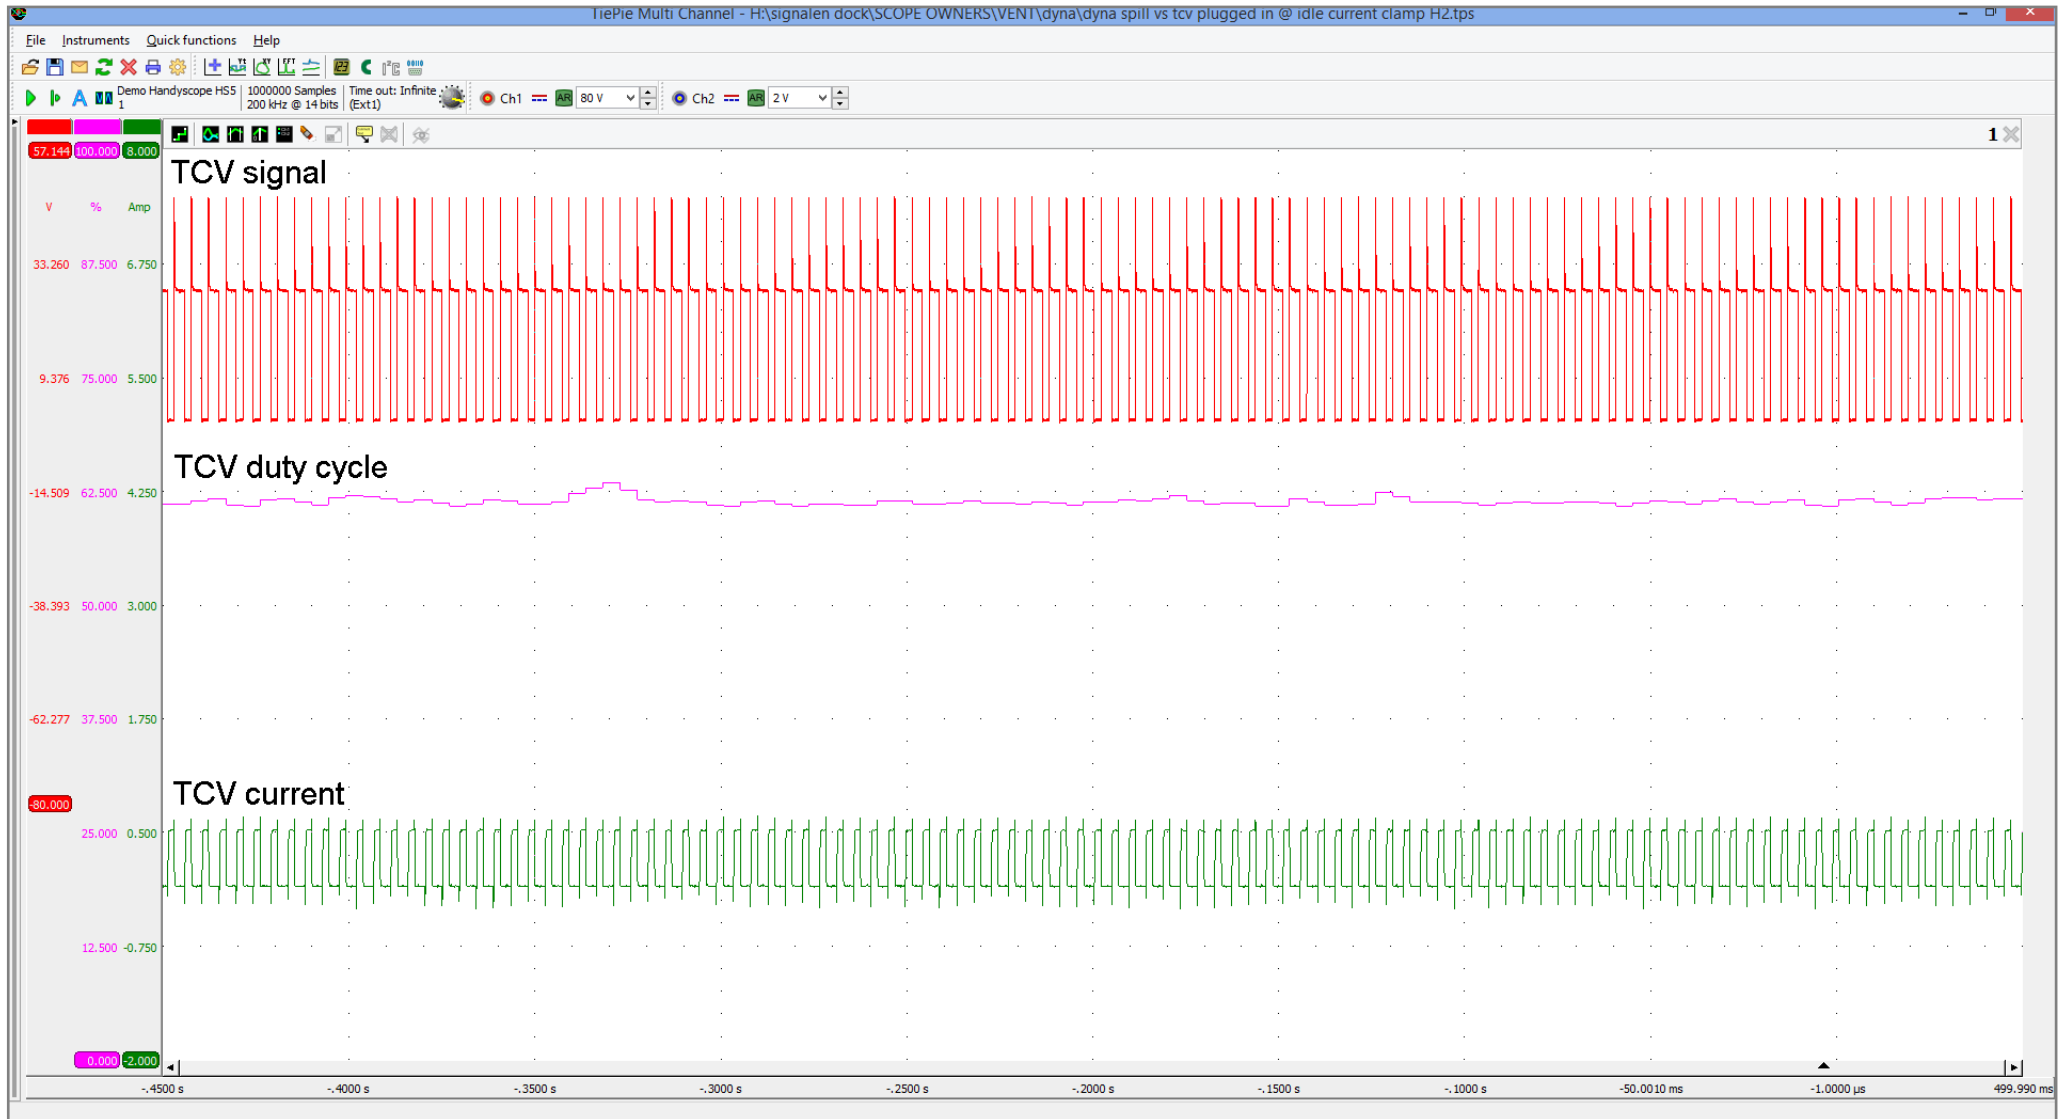
Picture 3: ATS scope recording of TCV voltage over current, running good (cold engine).
