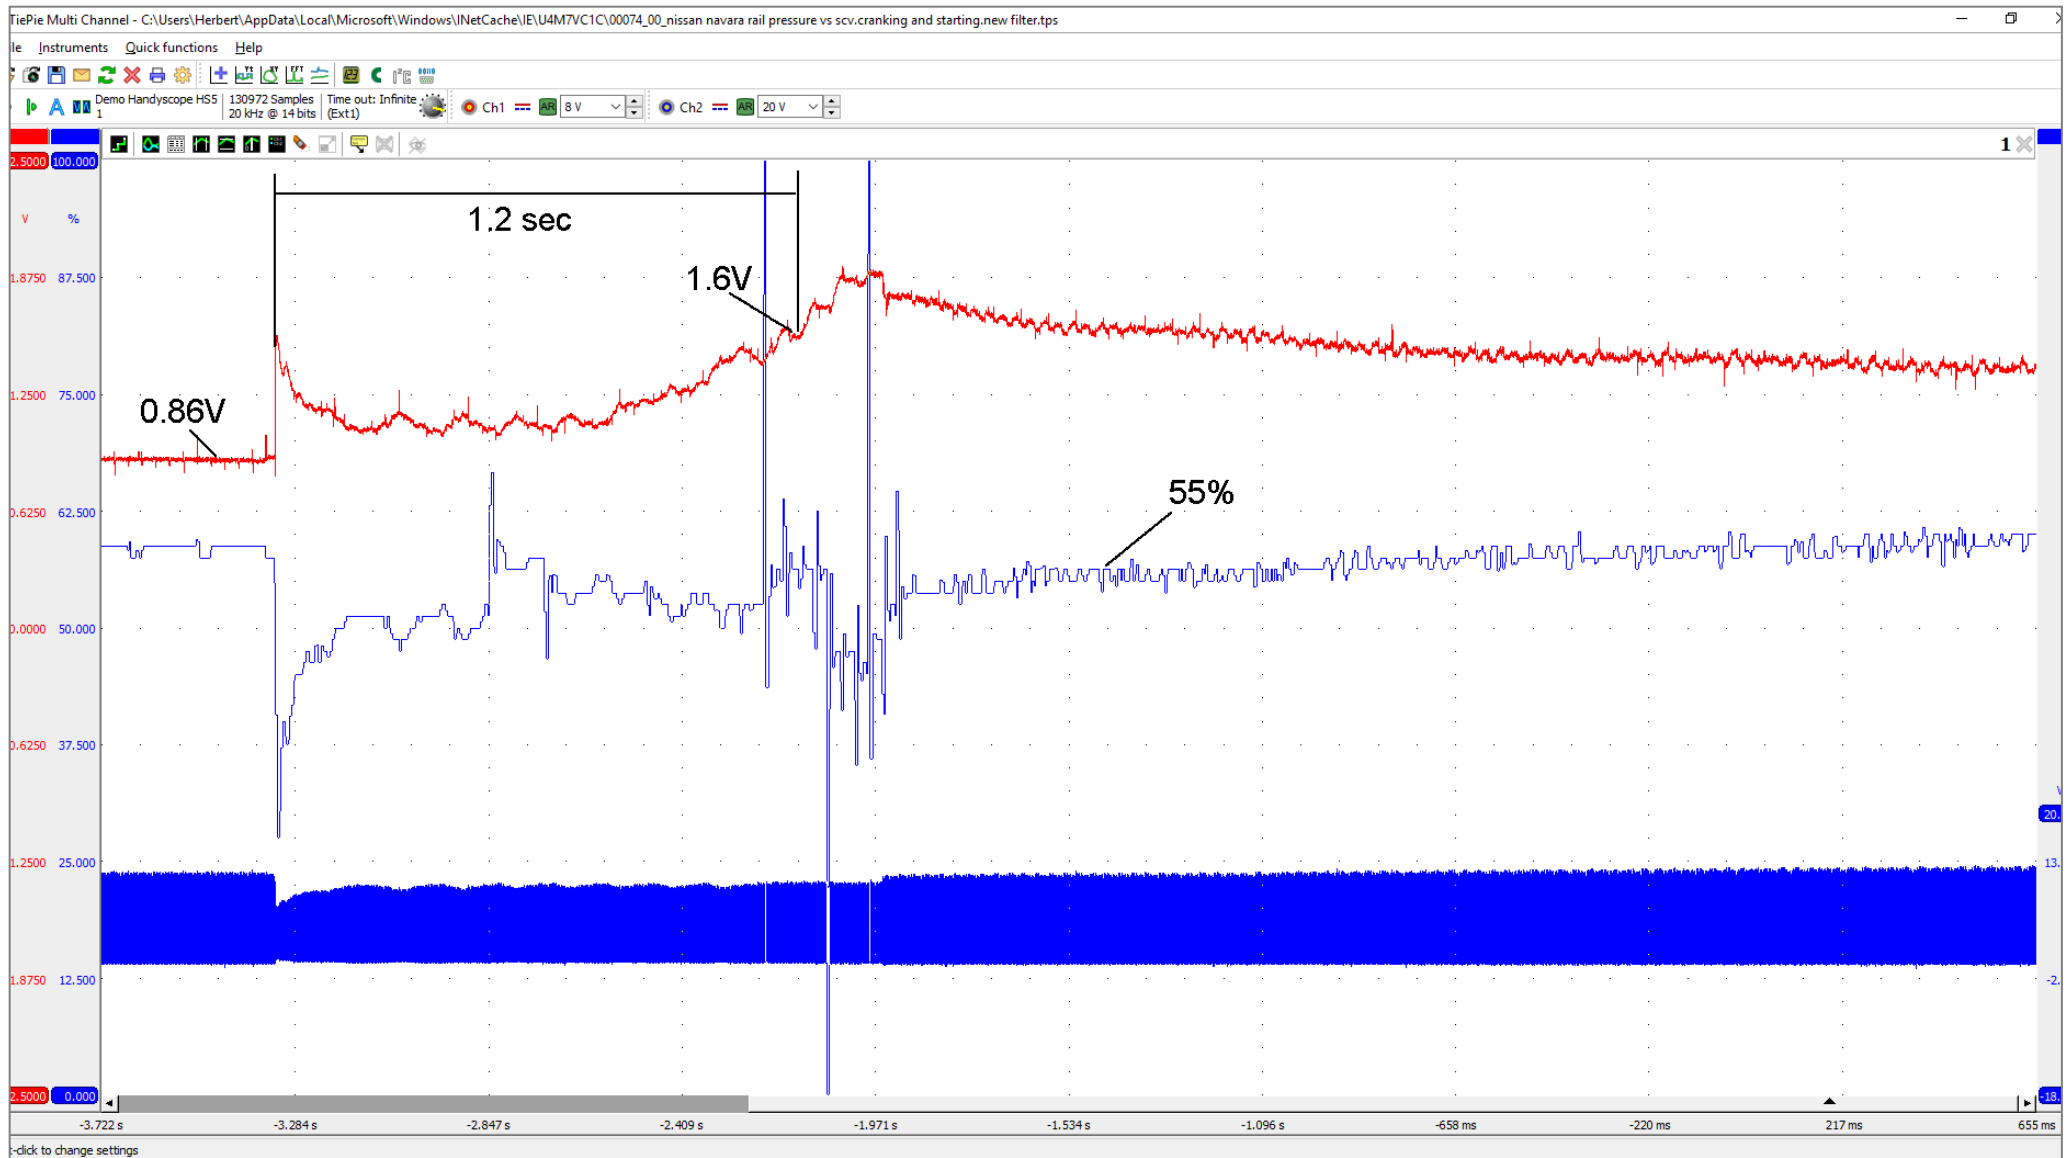
Picture 3: ATS scope recording of starting and firing up engine with the genuine filter fitted.
