March 2010 Technical Newsletter

Delicate Delica

Vehicle: Mitsubishi Delica 1999 2.5 ltr Diesel non turbo WL (Mazda) engine

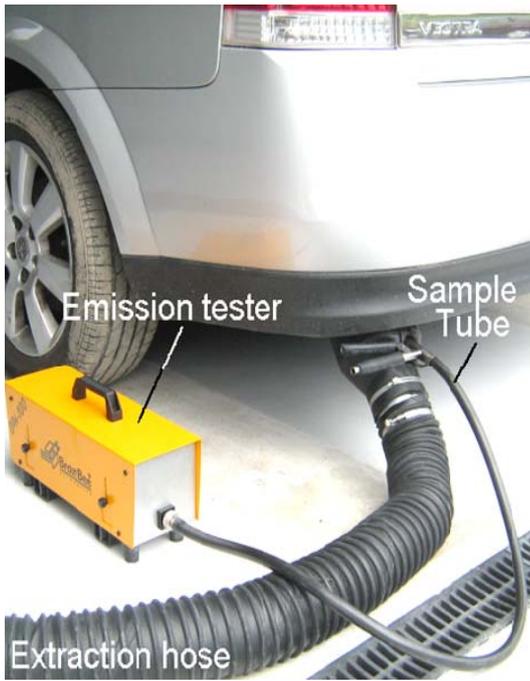
The measurements were performed on the road during full acceleration.

Sample picture of Diesel emission test in progress

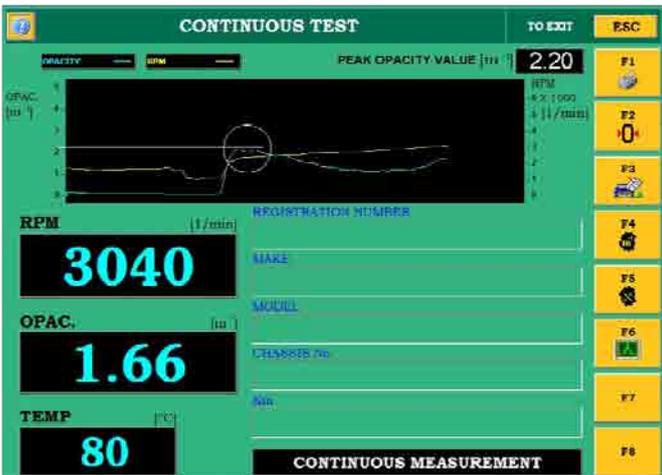
Laptop printout of Brainbee Opacity Emission test 1

It is clear to see in the graph that during acceleration the opacity climbs to an opacity of $K = 2.2 \text{ m}^{-1}$. The test was repeated again with the following results:

The first measurement is really the one we at the help desk were worried about. The low $K = 2.2 \text{ m}^{-1}$ compared to the mostly high results did not make sense. If a pump or injectors are at fault it seldom happens that the emissions are high one time and low another time while the same test is performed. This to me indicated that there was a pump control problem.

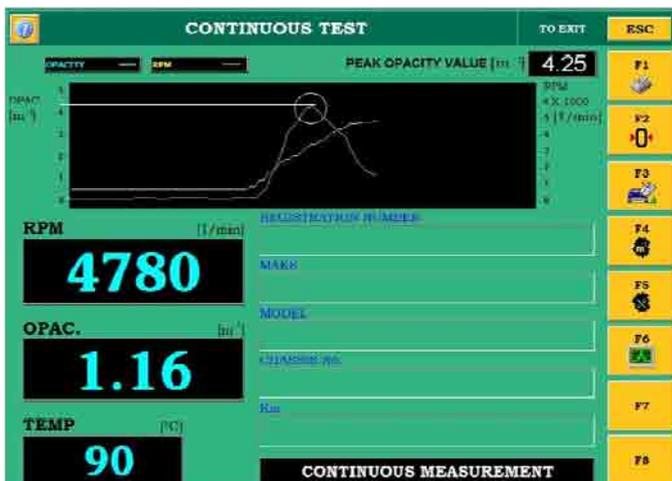
Brainbee Opacity Emission test 2

This time a peak opacity of $K = 4.25 \text{ m}^{-1}$ is logged.

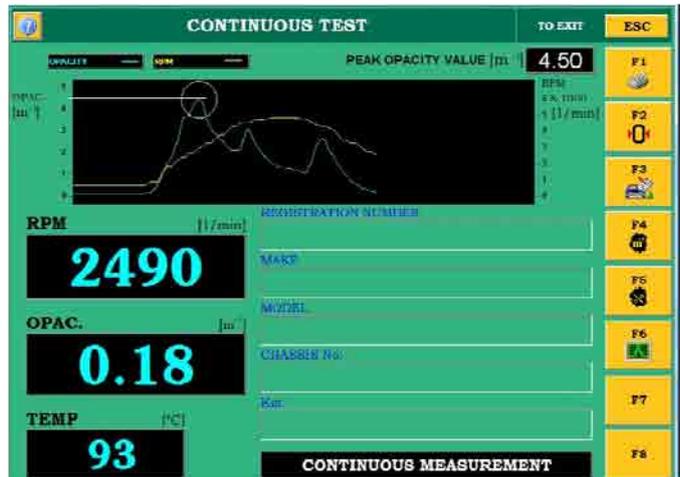
Brainbee Opacity Emission test 3

The same vehicle under the same circumstances logs a high peak opacity of $K = 4.5 \text{ m}^{-1}$.

A further set of tests was done with pretty much the same results, with the highest reading $K = 5 \text{ m}^{-1}$.

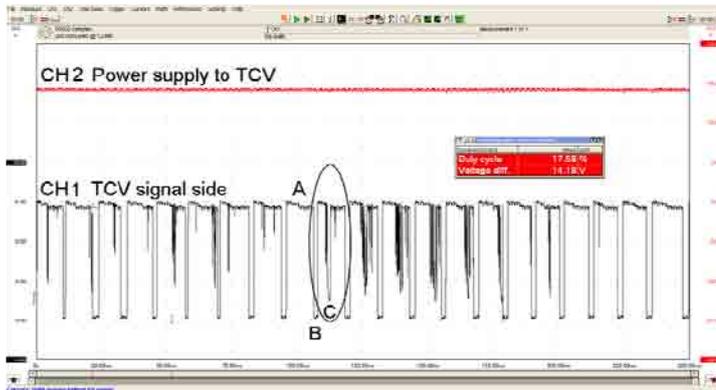
*ATS 5000 dual channel TCV recording.
A = non actuated, B = actuated, C = bad contact*

The signal on CH1 is not correct! The hash in between the actuations indicate that there is a bad connection or a short circuit somewhere, the signal on CH 2 indicates that at the same time the power supply to the TCV is fine.

- ▶ Consider that a short circuit to earth on the signal side of the TCV will actuate (open) the TCV uncontrolled. Anyone who attended the AECS Diesel training seminars will understand that an open TCV will retard the injection timing. The garage mentioned an intermittent rattle in the engine, which indicates overly advanced injection timing, so at this stage forget about a short circuit.
- ▶ Consider a bad connection between the TCV and the power supply wire or between the TCV and the signal wire in for example the connector. A bad connection will reduce the current and therefore the TCV will be less open, advancing the injection timing. This will cause Diesel knock, which ultimately destroys engines..... Big end bearing?

The diagnostician inspected the connector on the TCV and found that the two female terminals were stretched wide making intermittent contact. He suspected that the wiring loom hanging on the connector was too much over a period of time and caused the (expensive) damage.

He bend the terminals back and recorded the following pattern.

He replaced the terminals in the connector and the vehicle is going good now!

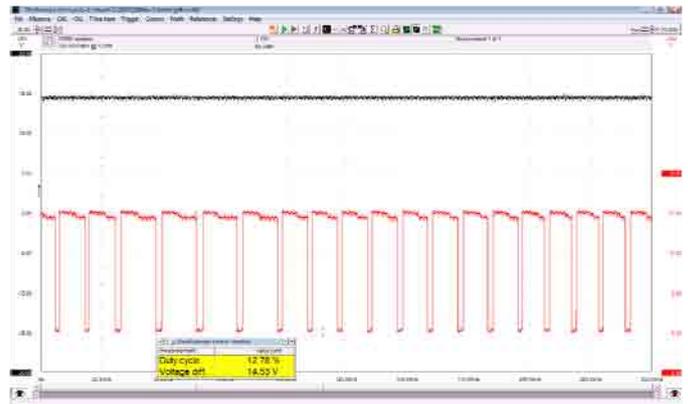
ATS 5000 perfect TCV signal after the repair.

He was able to charge the engine and diagnostic job out with the comfortable knowledge that the job would not come back to bite him. The emissions are down to a nice and clean $K = 1.2 \text{ m}^{-1}$.
