AECSTechnical Article ~ Crowbar Cefiro

1996 V6 2.5 ltr petrol VQ25DE Nissan Cefiro, Japanese import

Problem presented to the help desk: The car presented to this YES member is a taxi and came in with a slight miss at low revs and seemingly on one cylinder only.

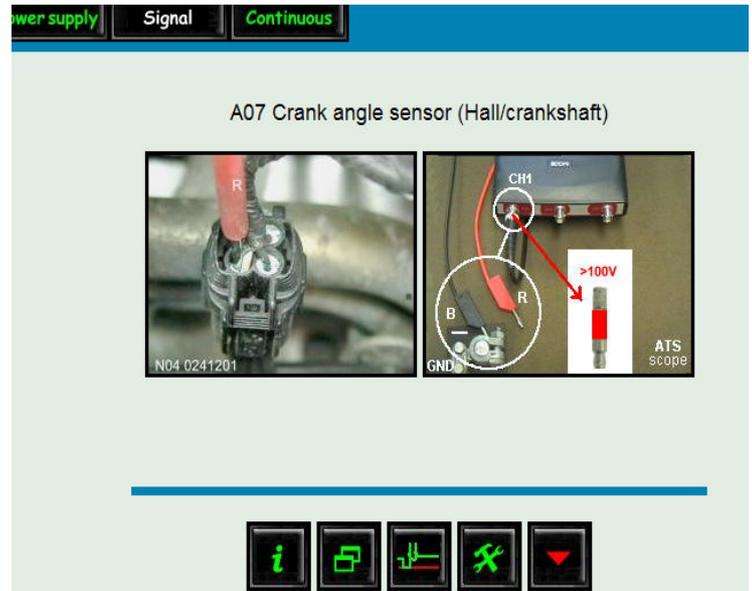
Figure 4

The ATS software clearly guides you with colour pictures (Figures 4 & 5) how to connect to the car's sensors and how to connect to the scope.
