# AECS Technical Article ~ Tragic Transit

This article is a true description of an AECS technical help desk problem and how it was solved.

1996 2.5 Ltr Turbo Diesel (EPIC) Ford Transit van

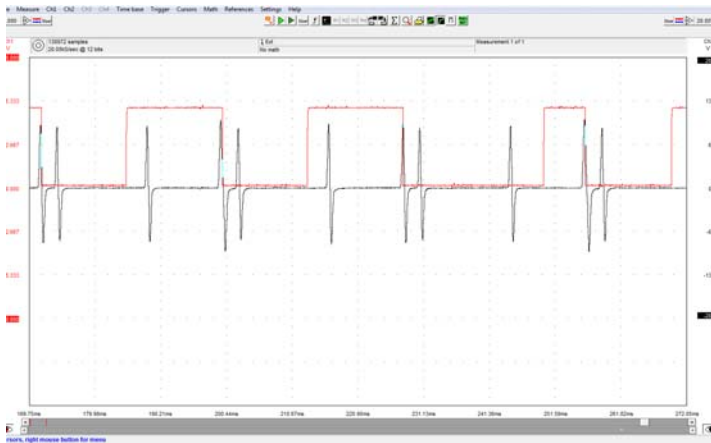
**Figure 3** Same recording again but now while the engine has settled for idle.

Same recording again but now while the engine has settled for idle. Look again at the relation between the two signals.

I am happy that the tiny variations between the sensors signals are not the cause of any limp home condition. That is 10 minutes or so in time down the drain, but at least we were sure.

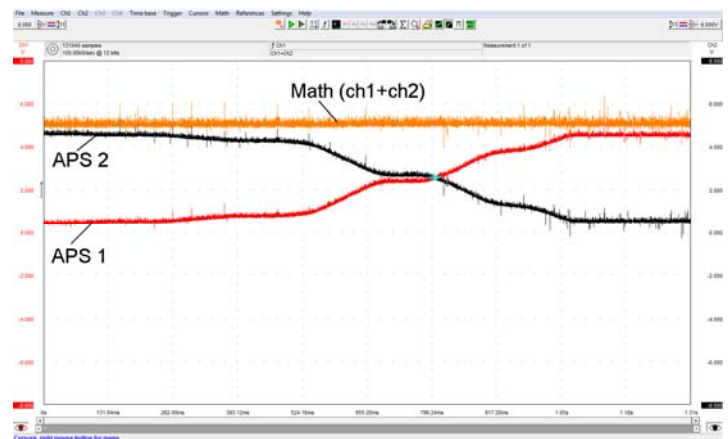
**Figure 5** Dual channel ATS 5000 recording with math function.

Despite the hash on the signal there is no obvious fault in any of the two signals.

The scope will run an extra trace where the voltages of channel 1 and channel 2 are added up (or subtracted). Since the two signals are each other's mirror image the outcome should be a steady 5 volt. With the math function you can see at any given moment if the signals stack up. A fault in one of the signals will affect the 'flat line' at 5 volts.

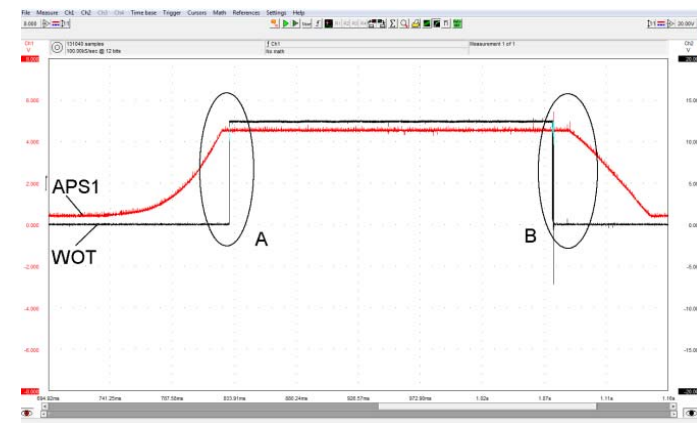
**Figure 8** APS 1 vs WOT switch.

It is clear to see that this is not okay! At A the wide open position has been reached some time before the switch opens. The same happens just before throttle back off at B. Also there is not a clear cut off line at B.

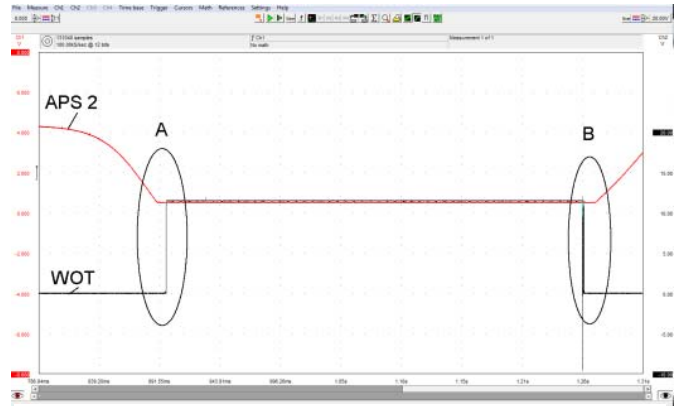
**Figure 9** recording of APS 2 vs the WOT switch

The same can be seen during the recording of APS 2 vs the WOT switch.

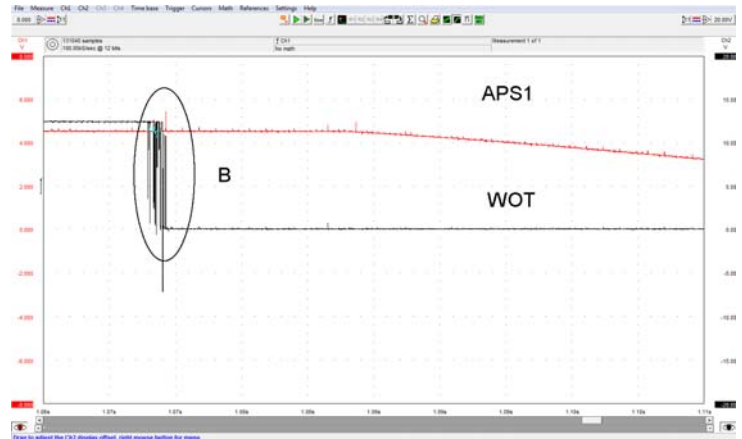
**Figure 10** APS 1 vs WOT switch recording zoomed in

The signal of the WOT switch flickers for a period of 1.5 milliseconds. This will send conflicting messages to the ECU!

Both the APS tracks inform the ECU of wide open throttle, yet the WOT switch sends a different message! Keep doing this for long enough and the ECU will not believe any of it anymore and falls back to idle limp home.

No the vehicle would not fail during the diagnostic process, but I am sure that this is where the problem came from. During full load driving (up hill loaded with passengers) the WOT switch gets actuated a lot and for a long period of time. During these prolonged periods you only need to have the switch playing up for a couple of seconds before the ECU decides that it has been enough.

The APS has been replaced and the vehicle has not played up anymore.
