May 2010 Technical Newsletter

Smoking gun

VW Golf 2001, 2 Ltr Petrol non turbo APK engine.

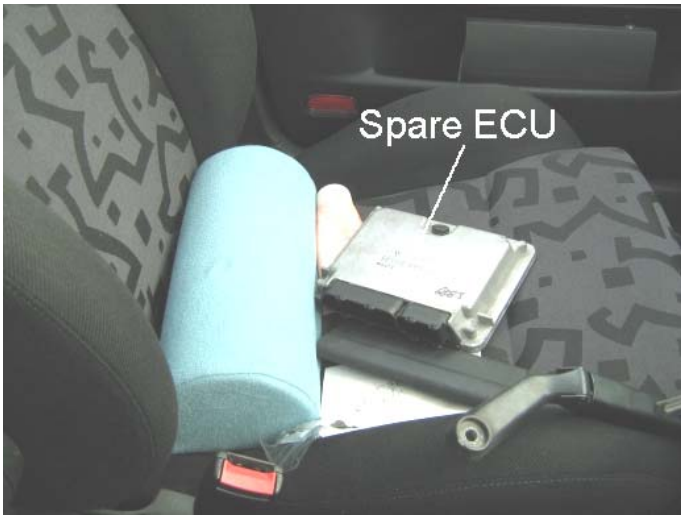
Ominous sign: The vehicle's original ECU (smoking gun) on the passenger seat

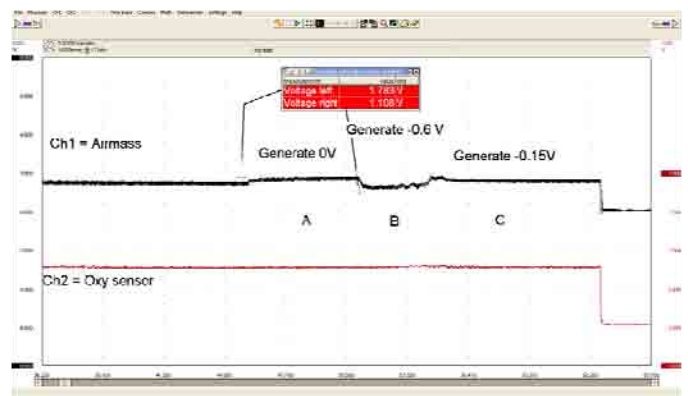
Scope Pattern 2: Air-mass vs oxygen sensor recording while modifying the air-mass sensor signal.

- ▶ At section A the engine is smoking black and running how it came in.
- ▶ At section B the air-mass sensor signal is lowered by 0.6V, this makes the mixture too lean, the engine struggles, please note that there is no change in the oxygen sensor signal.
- ▶ From section B to section C the simulator is slowly brought back to -0.15 Volt. This is where the engine runs reasonable well.

We had to lower the air-mass signal to reduce the quantity of fuel so the engine could start to run clean again in preparation for a new oxygen sensor. We sent out a -0.15Volt (negative!) signal, which made it run reasonable. At the same time we recorded the old oxygen sensor signal as by making the mixture lean we should see a difference.
