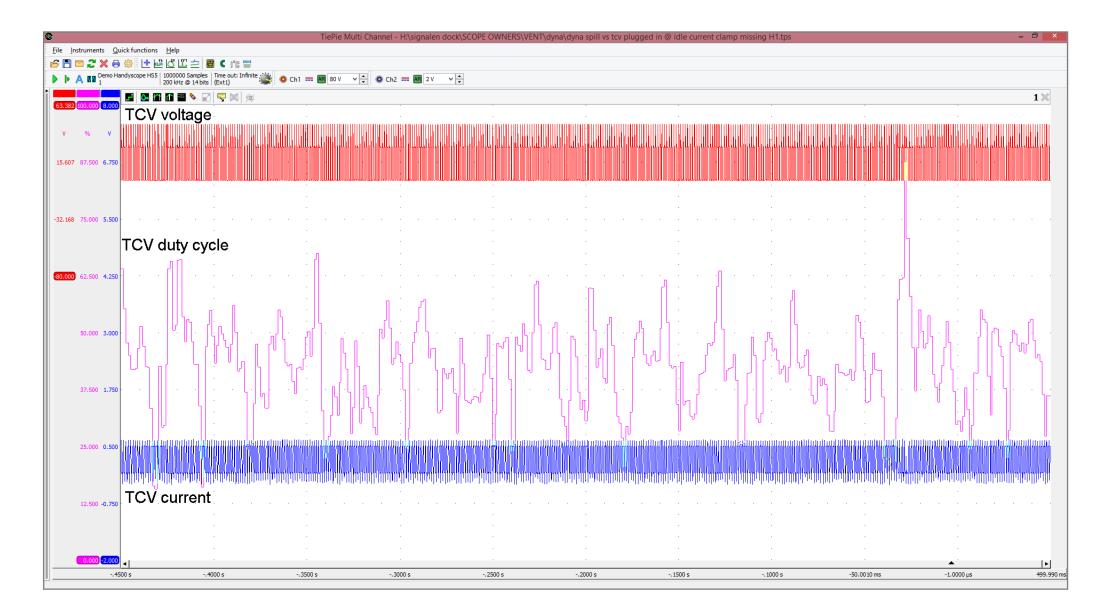
Picture 4: TCV voltage over current, running really bad (warm engine).
