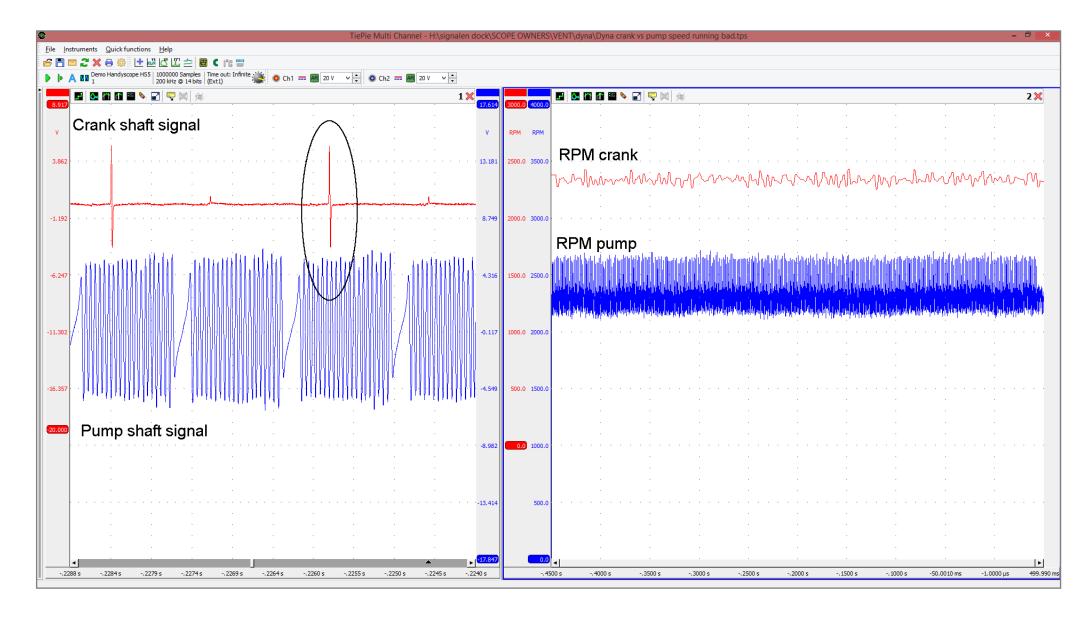
Picture 7: Split screen recording ATS 500XM of Pump shaft vs crank shaft sensor, when running bad.
